**International
Hurricane Research
Center**

Shelter and Component Testing OFDA transitional shelters: materials, techniques and structures

Shelter and Component Testing OFDA transitional shelters: materials, techniques and structures (Supplementary Test)

Project Number: WOW12-2012-02-A

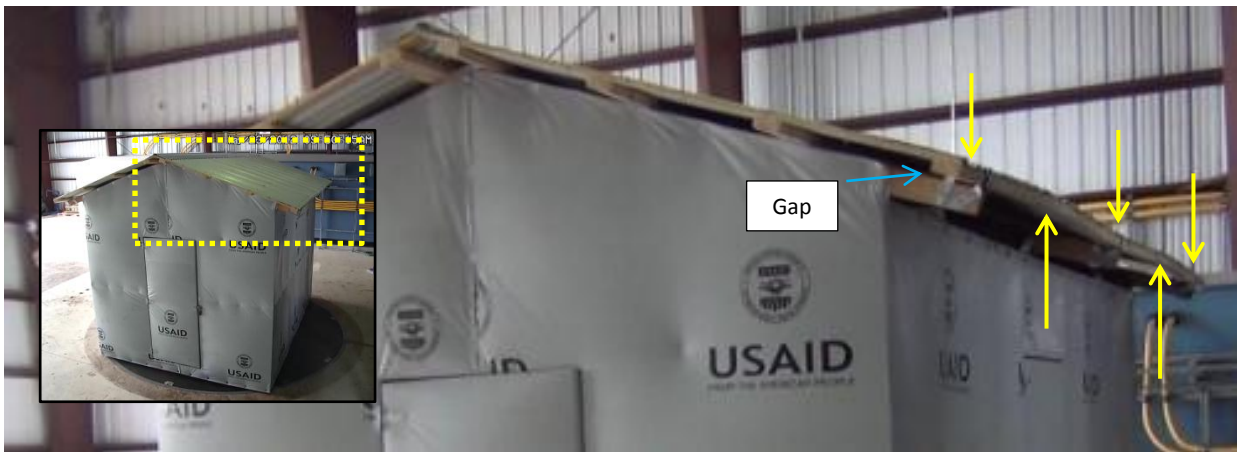
At the initial test speed (85 mph) it was observed that the T-Shelter structure was strong enough to be able to sustain the wind forces. No damage was noted on the framing or cladding. It is noteworthy to mention two effects on the T-Shelter as a result of the wind angle of incidence and the framing characteristics. At 0° there are sufficient uplift forces generated to cause a noticeable deformation on the leading edge purlin. A gap between the top chord of the truss and the purlin can be seen at one of the corners. The connections made with smooth shank nails were not adequate to prevent the nails from being pulled out under the uplift forces. The hurricane straps were shown to be effective to secure the purlins down to the trusses (Figure 4).

Figure 4 - Windward purlin deformation from uplift forces at 85 mph and 0° angle of attack

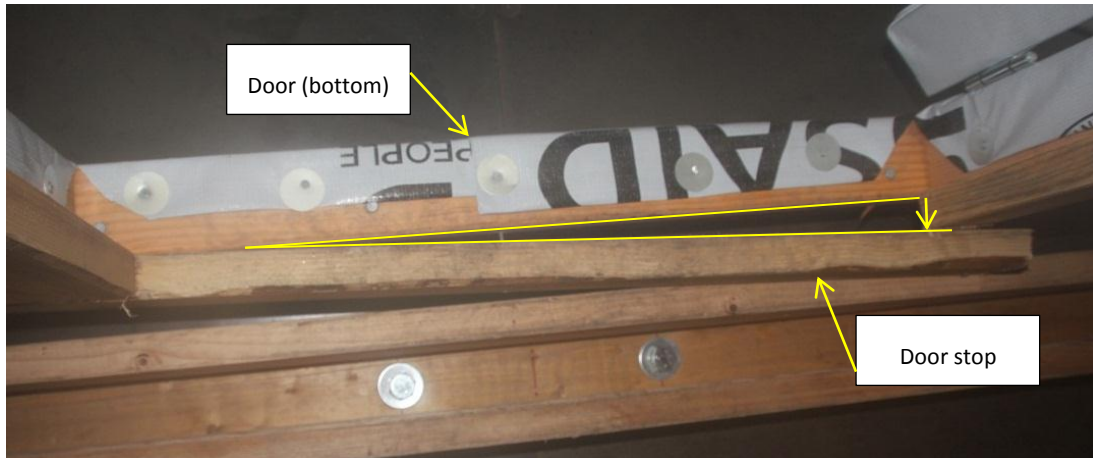
Furthermore, the increase in speed from 85 mph to 95 mph did not produce noticeable damage on the outside of the shelter. The additional lateral bracing seemed to be effective to transfer the forces and reduce the deflection at 90° angle of attack. The reinforced door hinges and door stop are believed to have provided additional support and strengthened the door system. No damage to the door was observed. While inspecting the inside of the shelter it was observed that the door stop did transfer the loads from the door to the frame. The bottom section of the door stop was partially pulled out from its attachment (Figure 6). This was a consequence of a construction flaw, where the nails were driven into the gap between the bottom plate and the platform.

Figure 6 - Bottom door stop pulled-out

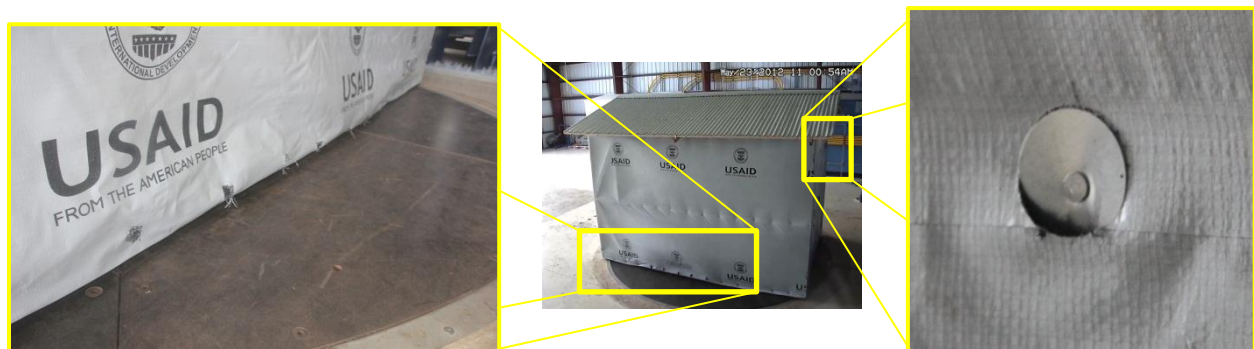
With the wind speed increased to 100 mph, sections of the OFDA plastic sheeting were pushed harder into the sharp edges of the tin caps. It is presumed that either the internal pressure build-up from air leaking through the shelter openings or the aerodynamic forces (suction) created on the wall surfaces, or a combination of both, caused the tin caps to start cutting through the plastic (Figure 7). It demonstrated that tin caps transfer the concentrated loads from the nail head to a bigger area on the plastic, but it's sharp edges can cut through it under repetitive loading. It is believed that a material with blunt edges (i.e. wood battens) might be a better option to enhance the durability of the USAID/OFDA plastic during repetitive loading and provide a surface to distribute the forces.

Figure 7 - Plastic puncture by tin cap discs

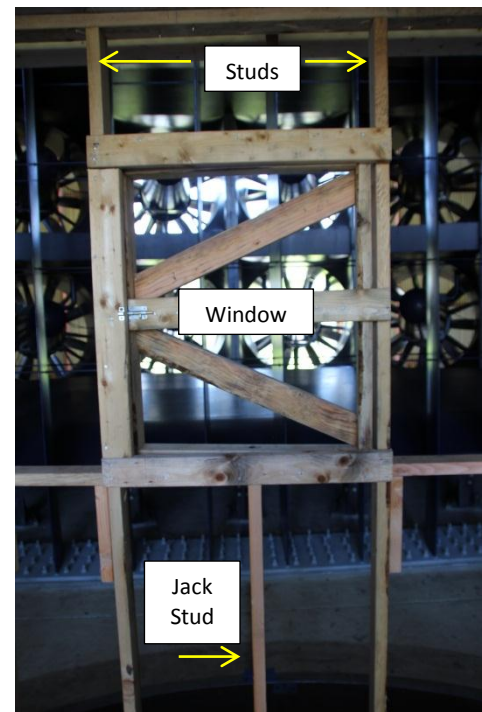
2. While reviewing the video it can be observed that there was a sudden deformation of the wall in its mid-section (close to 1 min into the test). The window section of the wall buckled inwards but did not detach from the rest of the frame (Figure 9). Until this moment the structure was still standing and the damage could have been repaired.

3. An inspection of the damaged wall after the test found that none of the studs around the window section fractured. Therefore, it is assumed that the wind-induced forces on the wall slowly pulled the nails out of the wood members that connected the studs to the top and bottom plates. There was no evidence of the nails failing from shear.

Figure 8 - Window framing

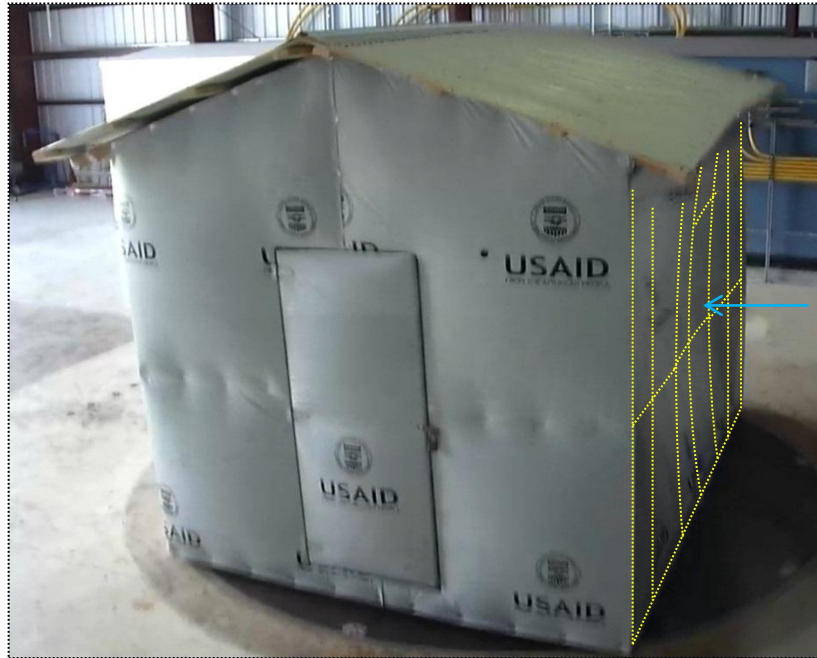
The frame on T-Shelter 3 failed at 110 mph and an angle of attack of 0°. It is believed that the failure mechanism is as follows:

4. After the windward wall collapsed, it provided no support for the middle roof truss.
5. The roof system was now supported by two trusses on each corresponding gable-end wall creating an unsupported span of 14-ft.

6. One of the hurricane straps that connected one of the gable-end trusses sheared and at that moment the roof system completely disconnected from the shelter's walls.
7. With no structural members supporting the mid-span wall section and the roof diaphragm gone, the walls collapsed under the wind loads.

Figure 9 - Windward wall deformation at 0° angle of attack and 110 mph

Considering the presumed failure mechanism, several key recommendations or modifications to T-Shelter construction should be considered:

- Adequate reinforcement at framing discontinuities must be provided to ensure the structure's ability to transfer the loads uninterruptedly to the foundation and distribute them along the structure. Door and window openings are discontinuities on the frame system that may become a weak point of the structure because of high stress concentrations on the discontinued frame members. Required elements to be included on the framing of door and window openings include: header, top cripples, and trimmer and jack studs (see Figure 10).

- Use of smooth shank nails should be discouraged. Ring shank nails were used for T-Shelter 3 only to fasten cladding to the frame. For these tests it was specified that framing should be done using 12D common nail. There is a big improvement in the pull-out resistance of ring-shank nails compared to smooth shank nails. The use of ring-shank nails is recommended for framing construction.
- To make the structures less vulnerable to failure under high wind conditions, a factor of safety should be incorporated into the different construction techniques. It was observed that there is no redundancy in the structural elements of the shelter. Once one of the members is weakened and fails the rest of the structure is compromised and most likely to collapse. By adding redundant elements, in case the roof fails, an internal or partition wall can help distribute the windward wall forces.

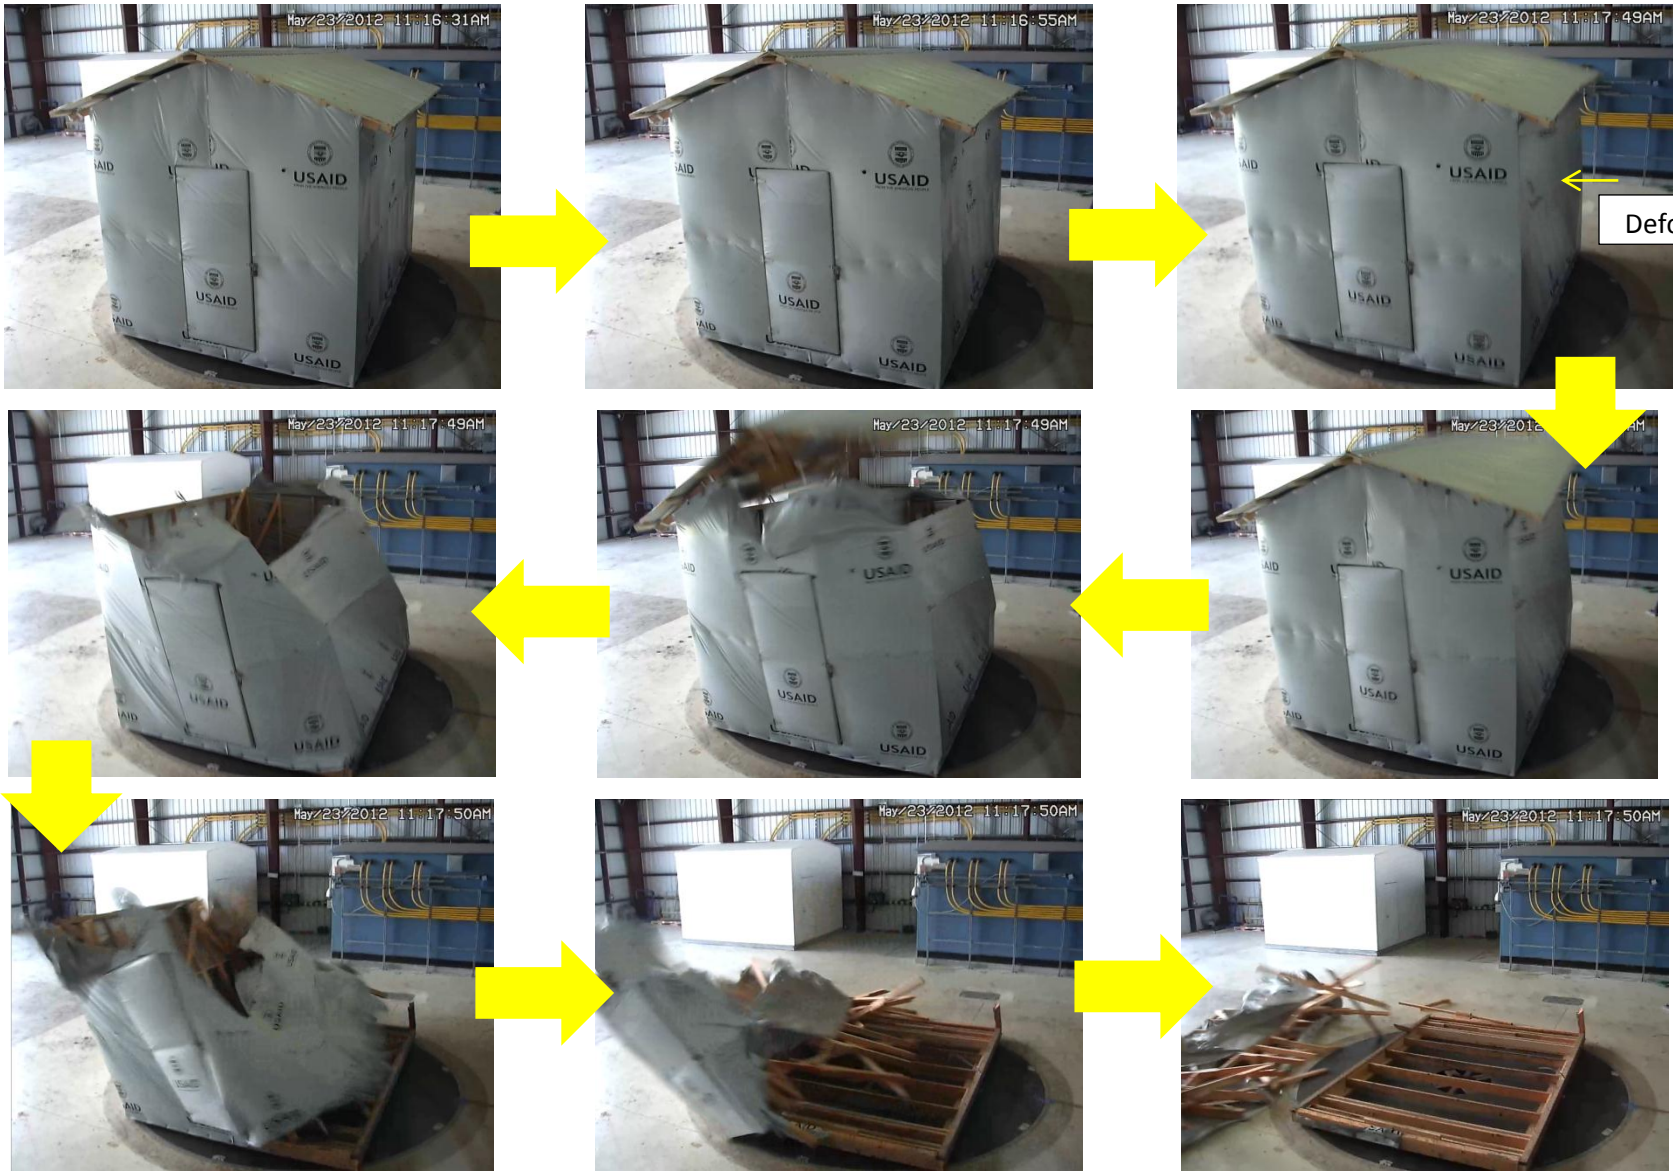
Figure 11 shows the images of T-Shelter 3 failure step by step.

Figure 11 - Shelter 3 failure

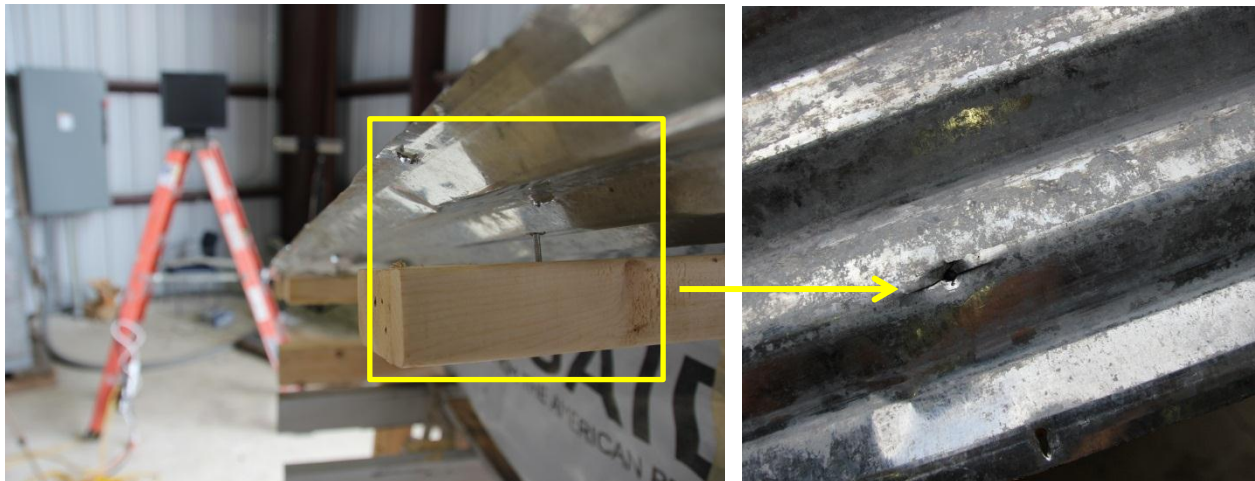
The performance of nontraditional roofing practices was investigated by evaluating the effectiveness of different roofing elements: cladding materials and fasteners. Light roofing materials have a lower capacity to take concentrated loads and therefore showed less ability to resist puncture at the points where the material was penetrated by fasteners. The loads were highly concentrated around the head of the nail and it was able to punch through the thin roofing sheet. This type of failure was observed on the test with wind perpendicular to the gable end wall, where the solid wall forces the flow to separate abruptly and a stronger uplift force was perceived. The damage happened specifically where no additional fascia board was provided along the edge of the roof. The number of nails on the gable end edge was restricted by the purlin ends available to nail down the sheet (4 purlins); therefore the forces were highly concentrated at these points. The nail heads were able to punch through the 32-gauge CGI sheet along the border at a wind speed of 70 mph (Figure 8).

Figure 8 – Nails punctured the 32-gauge CGI roofing sheet on gable end at 70 mph wind speed

In both cases where the roof cladding became partially or totally detached from the purlins, a simple change to the structure and fastening method secured the cladding. A fascia board was nailed to the purlin free ends on the gable end. This additional board allowed fastening the sheets of roof cladding with a shorter spacing between fasteners: every 12-in instead of every 24-in. Retesting the retrofitted setup confirmed that none of the sheets were punctured and that all the cladding stayed attached to the roof structure (Figure 10).

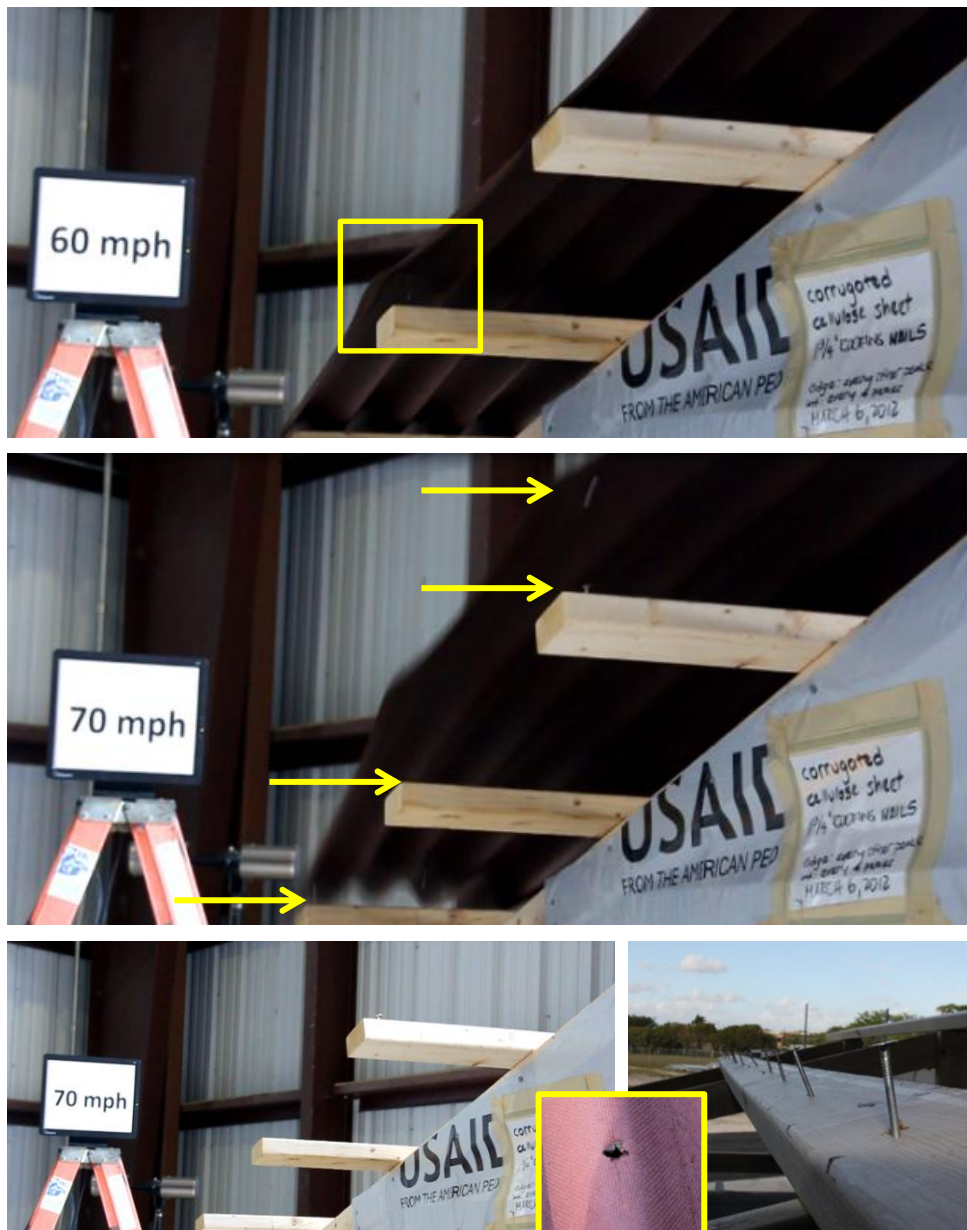
A similar failure was also observed with the corrugated bitumen saturated cellulose fiber sheets (CBCF) and 1 ¼-in roofing nails. In this case, the failure occurred at the gable end of the roof as well but translated to the rest of the fasteners producing a whole roof system failure. The roof breakdown happened at a speed of 70 mph, but some of the nails can be seen pulled out of the wood at 50 mph and 60 mph. The CBCF sheets can be seen bulging around the gable end edge due to insufficient fasteners along the border of the sheet and the flexibility of the material. All of the CBCF sheets were blown off the roof section at 70 mph. Some of the nails perforated the cellulose sheet while some were pulled out of the wood purlin and stayed connected to the CBCF sheet. These show two types of

Figure 9 – Failure of cellulose-bitumen sheet by fastener puncture of the roofing material

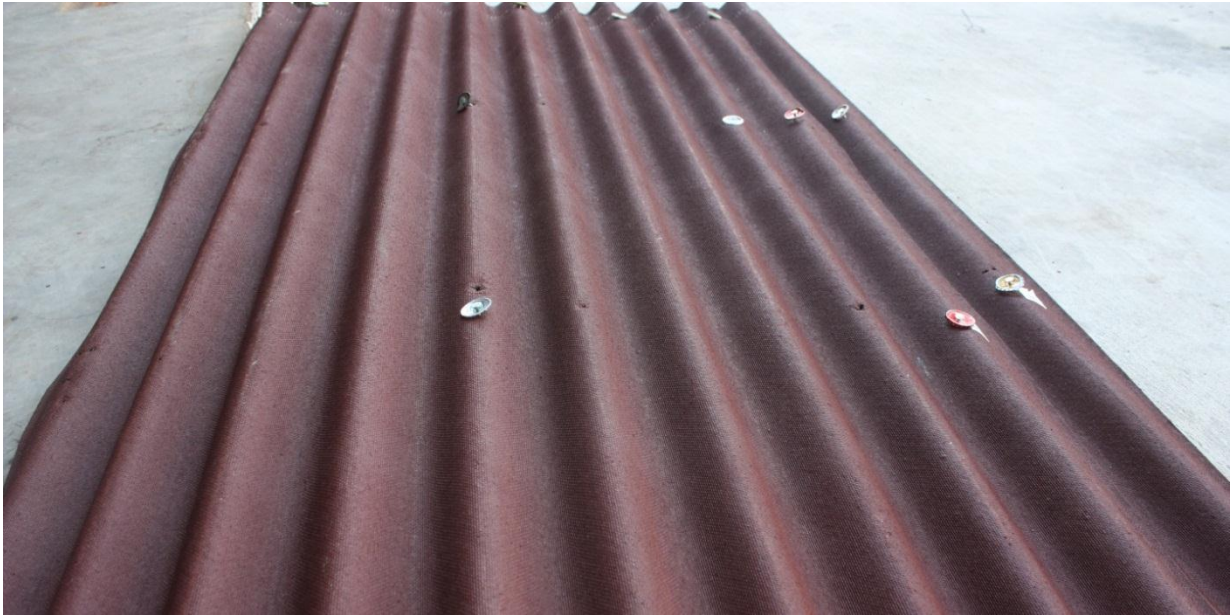
The addition of bottle caps as washers to the 2-in roofing nail did not improve the performance of the roof system. The smooth nail shank together with the 1 ¼-in corrugation height and 2-in roofing nail did not provide a secure fastening method for the cellulose-bitumen panel. The nail heads did not puncture the panel but were pulled out of the purlin while staying attached to the bottle cap and roof panel (Figure 11).

Figure 11 - CFBF sheet detached from roof supporting structure, seen here with roofing nails and bottle caps still attached

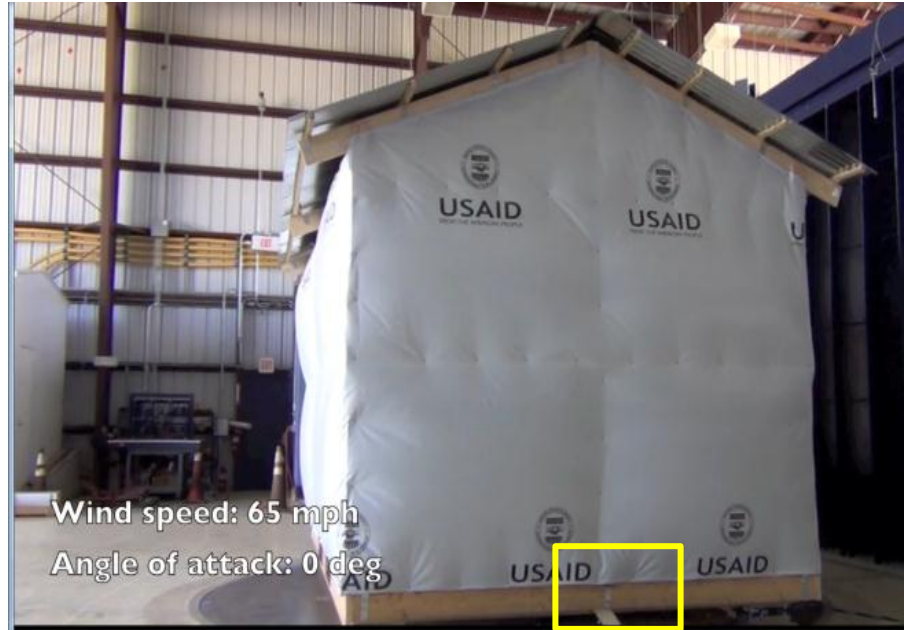
Figure 22 – T-Shelter 1 test at 65 mph and 0° and 90°; some of the wood boards part of the framing detached

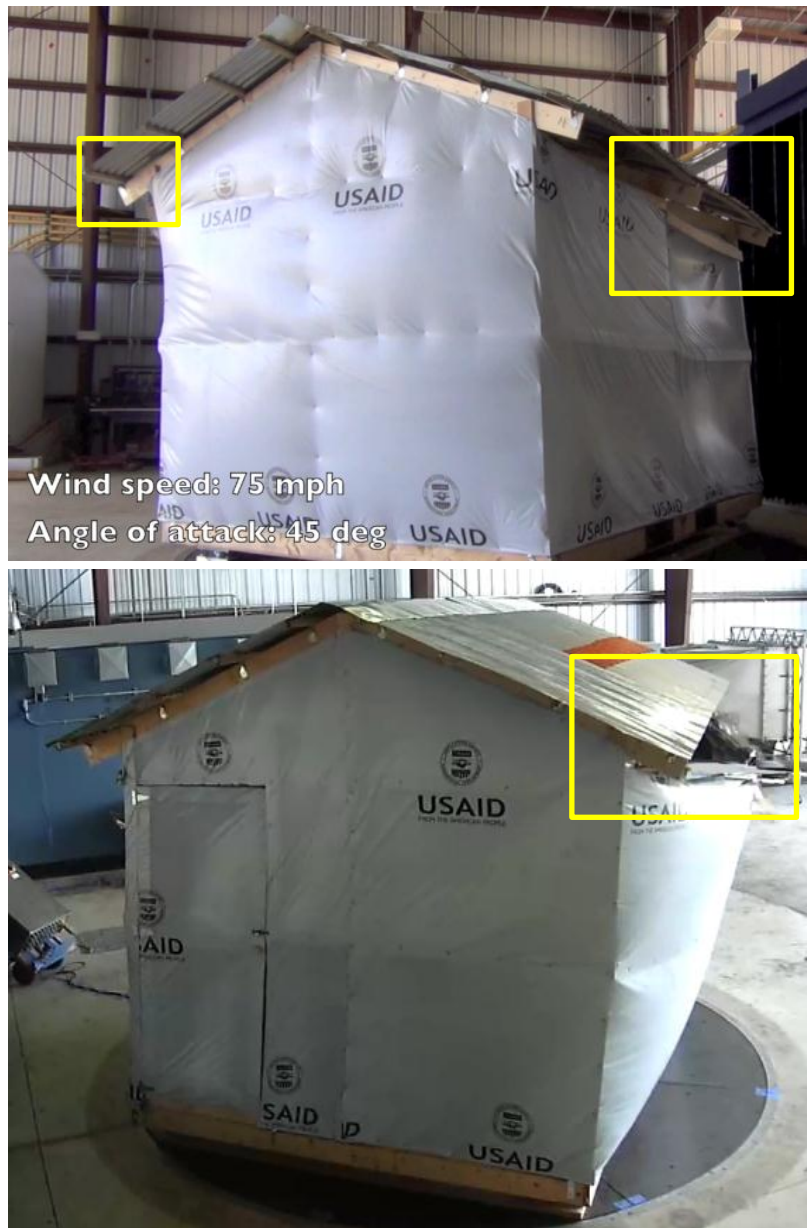
Figure 23 - Test at 75 mph and 45°; horizontal members detaching from framing

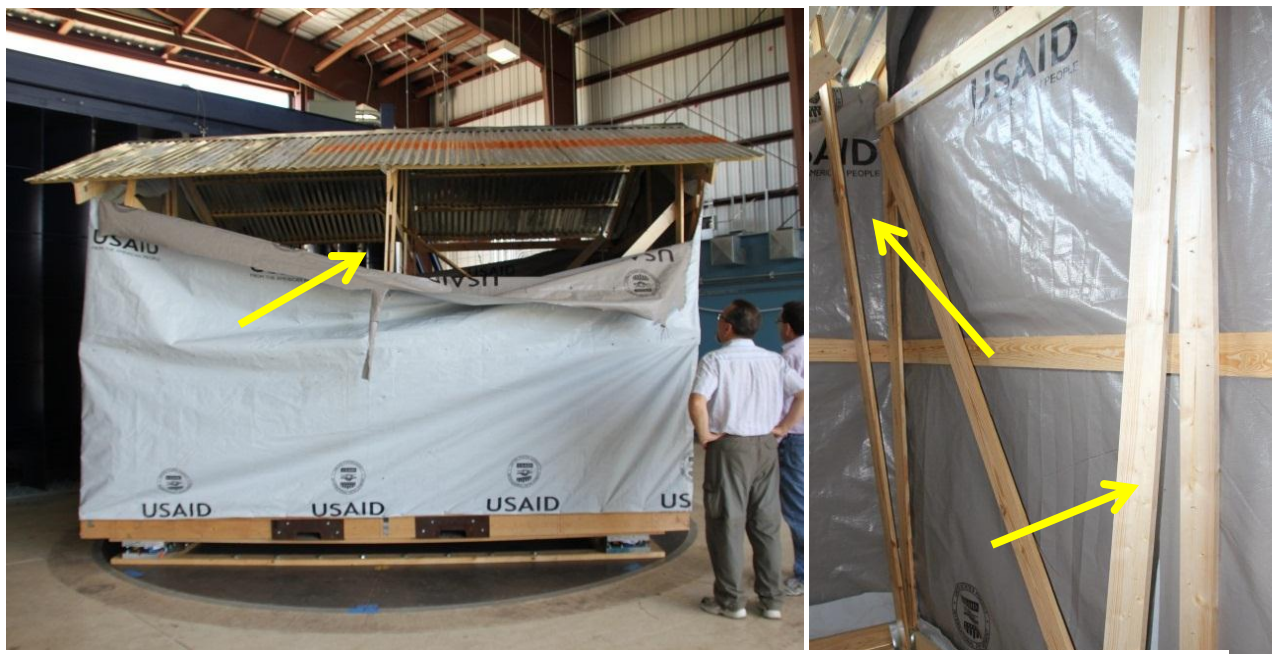
Figure 24 - Nail pull-out failure on shelter framing at 75 mph

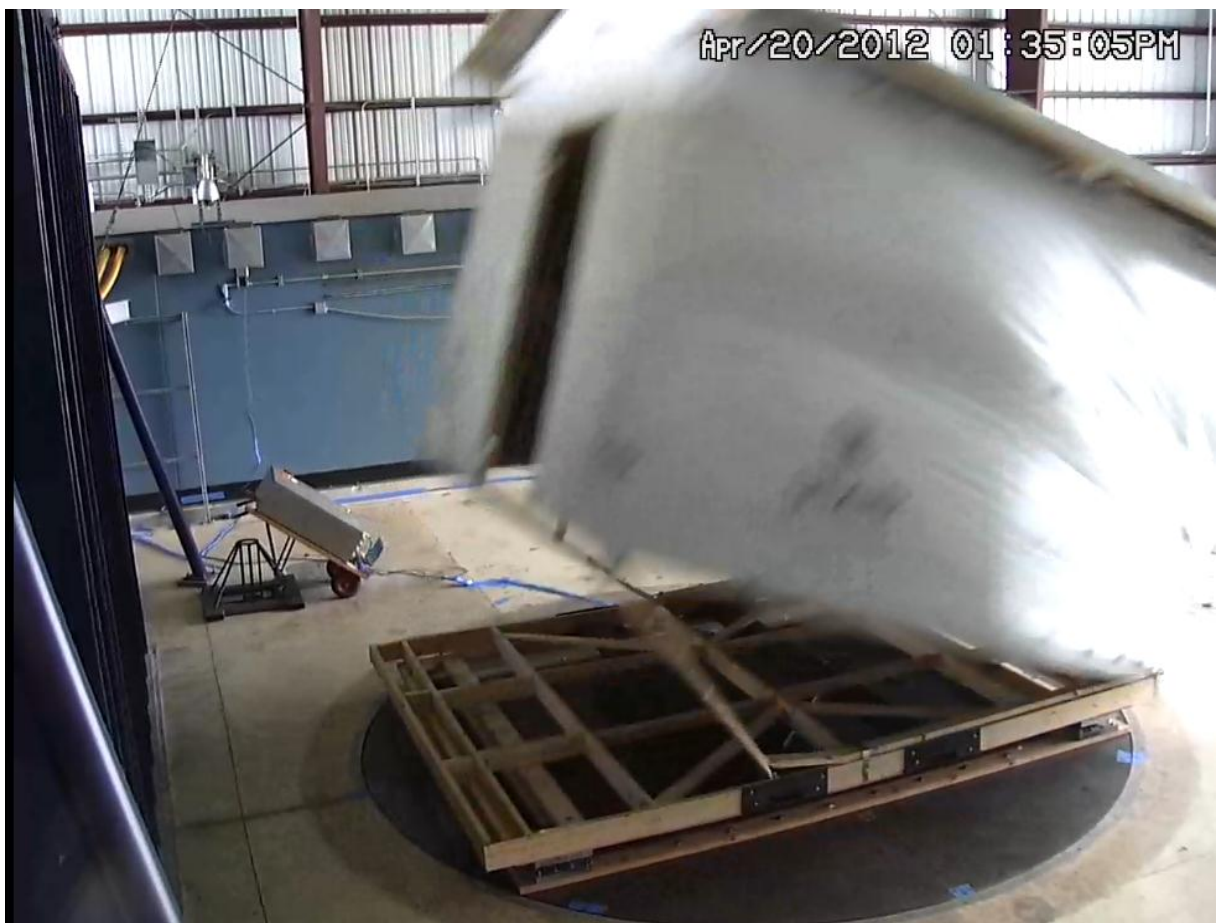
Figure 29 - Platform base failure due to increased uplift tension on wood members

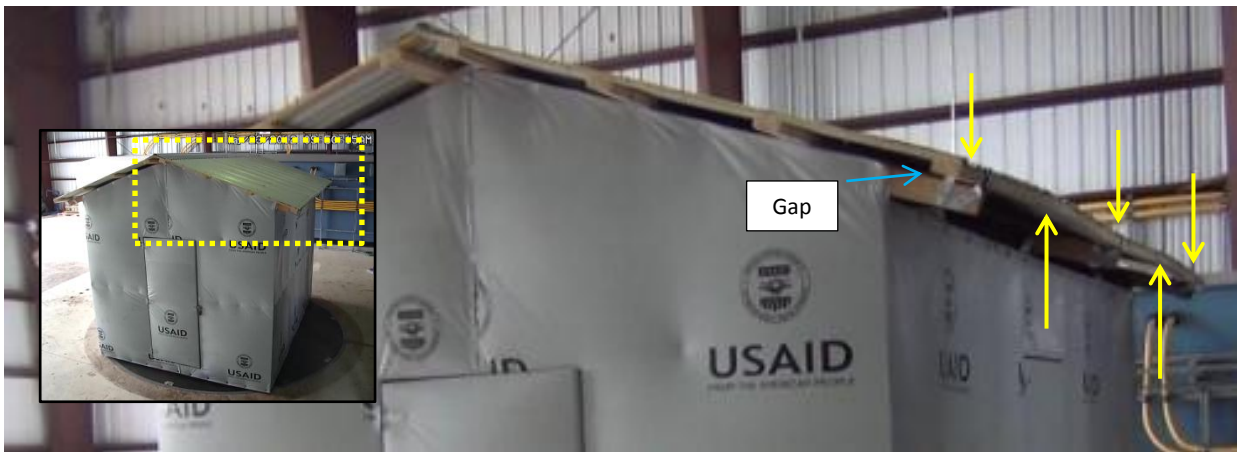
Figure 4 - Windward purlin deformation from uplift forces at 85 mph and 0° angle of attack

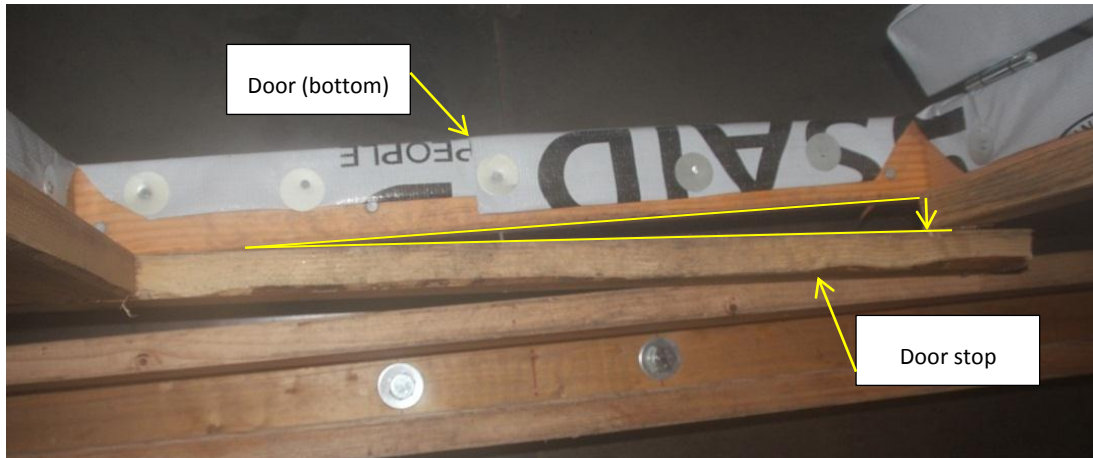
Figure 6 - Bottom door stop pulled-out

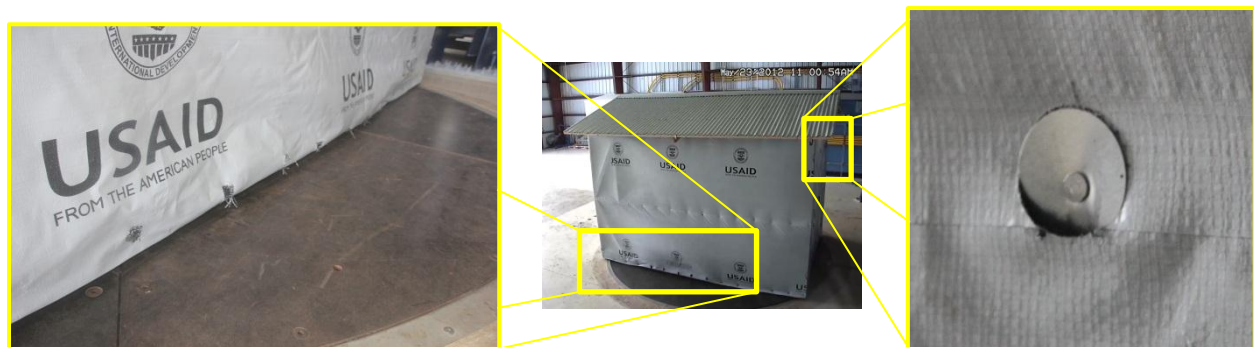
Figure 7 - Plastic puncture by tin cap discs

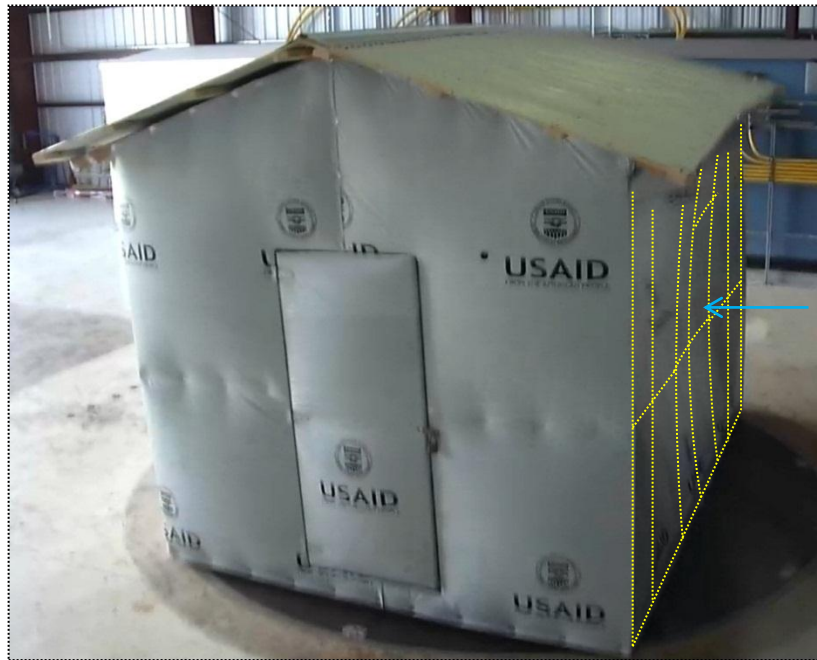
Figure 9 - Windward wall deformation at 0° angle of attack and 110 mph

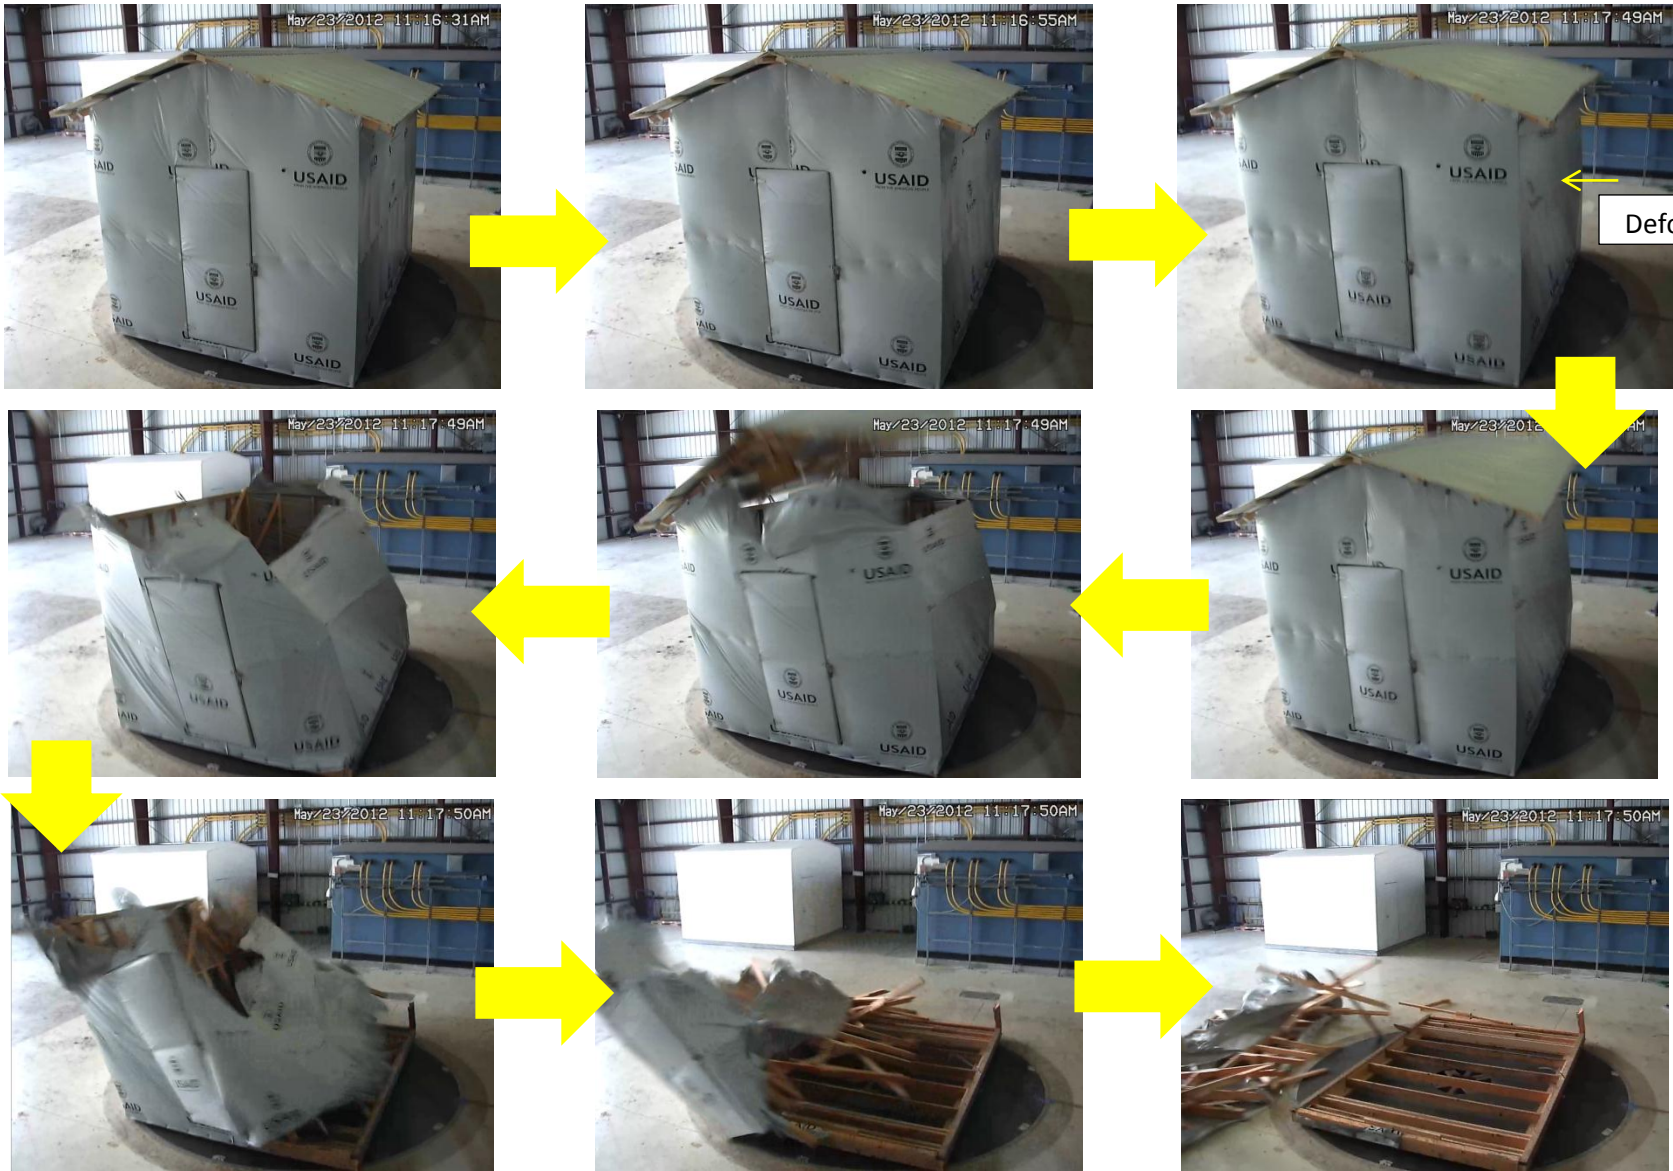
Figure 11 shows the images of T-Shelter 3 failure step by step.

Figure 11 - Shelter 3 failure
