**Progress Report: March 1, 2013, to March 31, 2013**

USAID contractors continued implementing the Environmental Remediation of Dioxin Contamination at Danang Airport project launched in August 2012.

## Vietnam: Environmental Remediation of Dioxin Contamination at Danang Airport

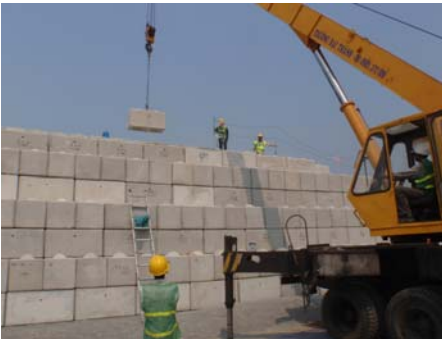
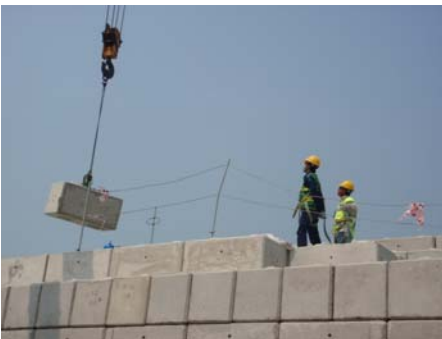
To protect workers who are building the containment structure walls, a fall protection system was designed, built, and installed for all work conducted higher than two meters. A training class was designed and held for all workers to review fall protection procedures.

Fall protection equipment (Photo: CDM Smith)

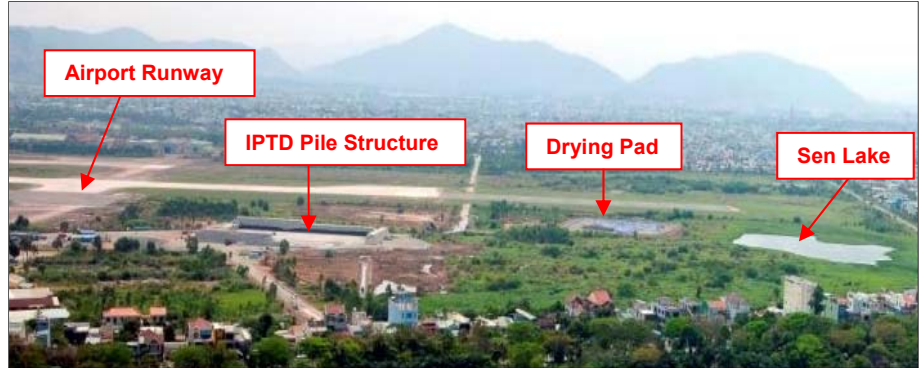
Panoramic view of the project site, looking west (Photo: David Liu, Tetra Tech)

USAID contractors continue building the containment structure. The wall now stands at 7.3 meters in the southeast corner (see photos above and below). Contractors are installing a very strong, thick plastic liner on the bottom of the structure to prevent any water from draining out or entering the treatment system once operational.

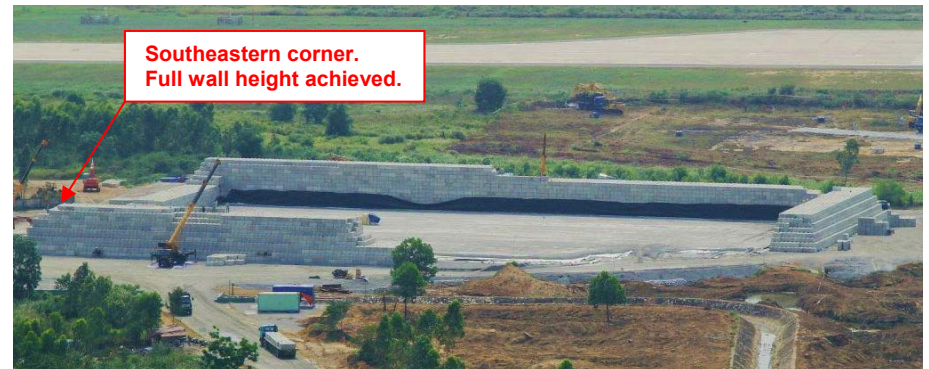
Pile containment structure (Photo: David Liu, Tetra Tech)

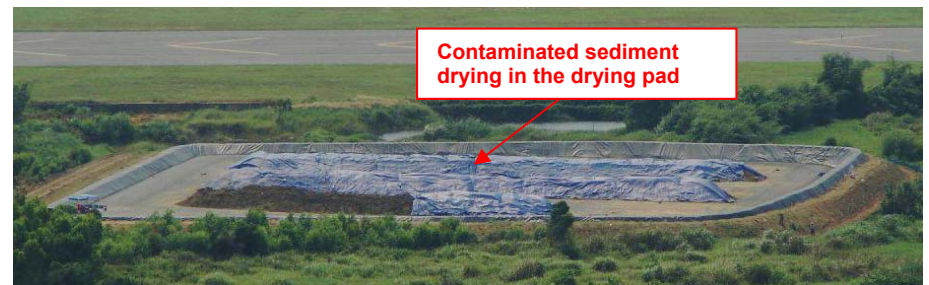
USAID contractors completed construction of the drying pad (see photo below). The drying pad is being used to safely dry and store wet soil and sediment until it is ready to be loaded into the pile containment structure. To date, approximately 3,200m<sup>3</sup> of contaminated sediment from the southeastern wetland has been placed in the drying pad for dewatering before it is moved to the treatment pile. All drainage water from the drying pad is collected and tested prior to being discharged.

Drying pad (Photo: David Liu, Tetra Tech)

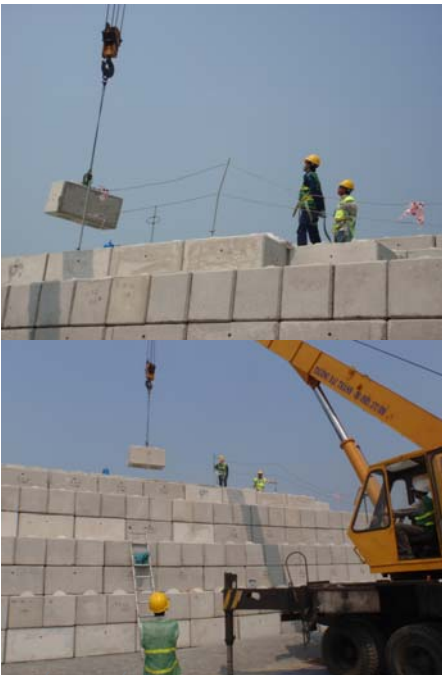
Nhằm bảo vệ công nhân xây lắp tường chắn, một hệ thống chống trượt ngã được thiết kế, thi công và lắp đặt cho tất cả công việc được thực hiện ở độ cao trên 2 mét. Công nhân được huấn luyện để nắm bắt các quy trình chống trượt ngã này.

Thiết bị chống trượt ngã Ảnh: CDM Smith)

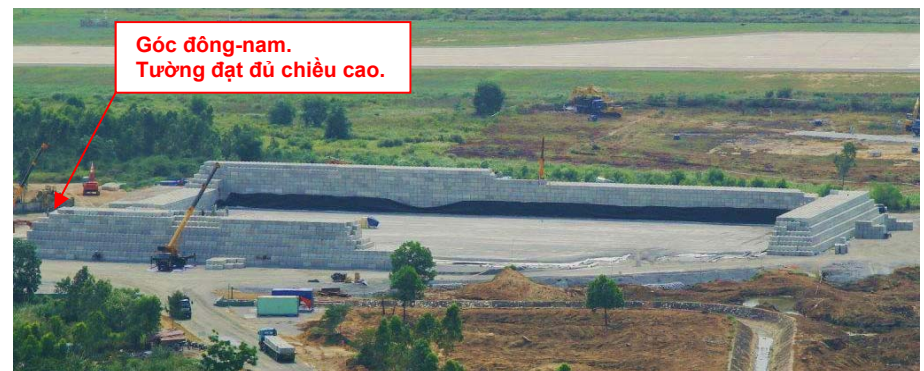
Các nhà thầu của USAID tiếp tục thi công kết cấu móng. Tường chắn hiện đã đạt đủ chiều cao 7,3 mét ở góc đông-nam (xem ảnh trên và dưới). Các nhà thầu đang lắp đặt một lớp lót bằng nhựa dày, rất chắc, trên nền của kết cấu nhằm ngăn chặn nước rò rỉ ra ngoài hoặc nước bên ngoài ngấm vào trong hệ thống xử lý trong giai đoạn vận hành.

Kết cấu móng xử lý

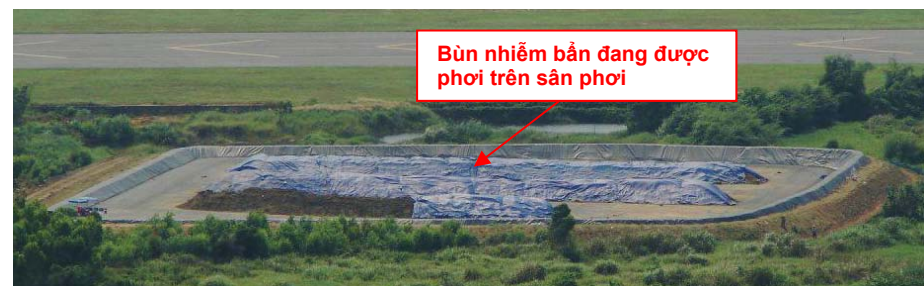
Các nhà thầu của USAID đã hoàn tất thi công sân phơi (xem ảnh bên dưới). Sân phơi này được dùng để phơi và tập kết một cách an toàn đất ướt và bùn trước khi đưa đất và bùn này xử lý trong mỏ. Cho đến nay, khoảng 3.200m<sup>3</sup> bùn bị nhiễm bẩn từ khu vực đất ngập phía đông-nam đã được đưa vào sân phơi để giảm lượng nước trước khi đưa vào mỏ xử lý. Toàn bộ lượng nước rỉ ra từ sân phơi được thu gom và phân tích trước khi xả ra ngoài.

Sân phơi
