Progress Report: June 1, 2013 to June 30, 2013

USAID continued implementing the Environmental Remediation of Dioxin Contamination at Danang Airport project launched in August 2012.

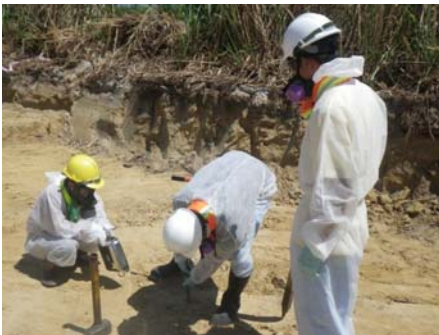
Confirmation soil sampling (Photo: CDM Smith)

USAID contractors continued extensive monitoring, inspection, and testing to ensure no contamination leaves the project area and that construction activities meet design specifications. In addition, USAID contractors continued to collect confirmation soil samples from the excavation limits to ensure the removal of all contamination. All confirmation sampling is being conducted in close coordination with the Vietnamese Ministry of National Defense Chemical Command and the Vietnam-Russia Tropical Center.

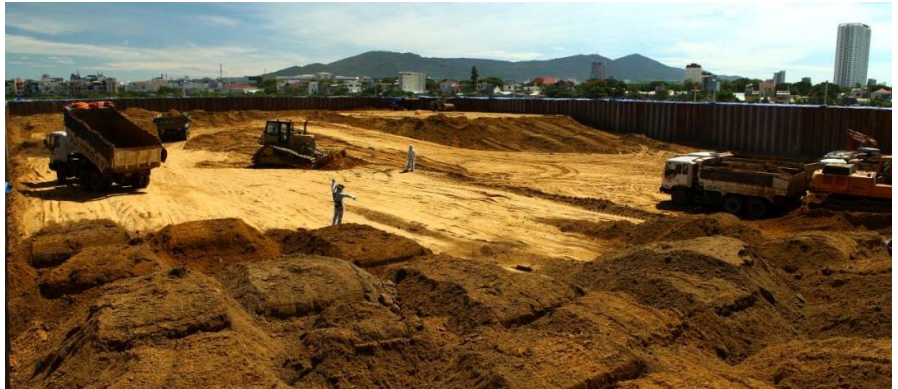
During June 2013, USAID contractors continued building the containment structure, continued excavating contaminated soil near the airport runway, and began transporting contaminated soil and sediment from the former storage areas and southern wetlands into the containment structure (see photo below). During these activities, water was sprayed on the soil and sediment to prevent any contaminated dust from being released into the air. As of June 30, approximately 50 percent of the containment structure had been filled.

Placing contaminated soil and sediment in containment structure

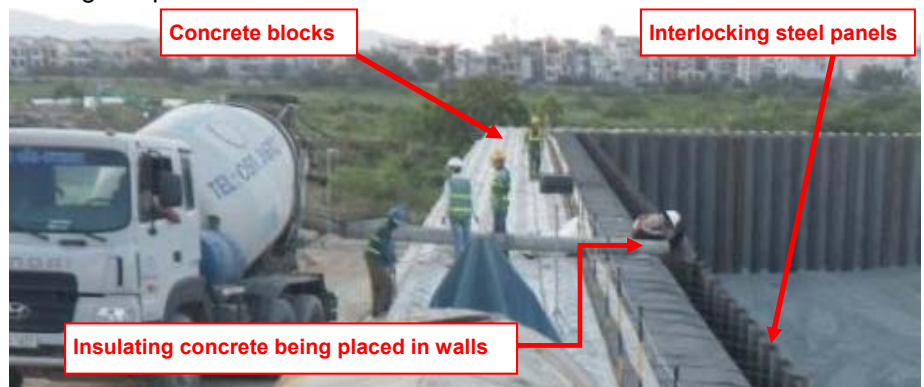
The side walls of the containment structure (consisting of concrete blocks, insulating concrete, and interlocking steel panels – see photo below) are nearing completion.

Concrete blocks

Interlocking steel panels

Insulating concrete being placed in walls

Pouring insulating concrete into the containment structure walls

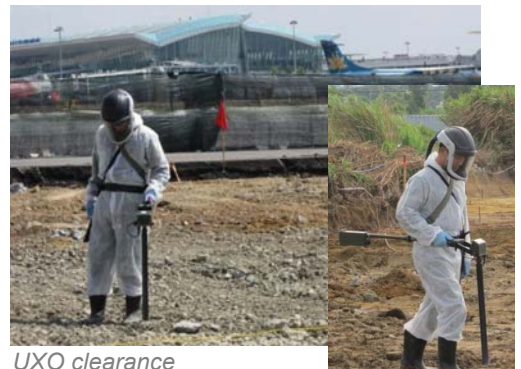
Before soil excavation began in the former mixing and loading area near the airport runway, USAID contractors demolished and safely removed a concrete containment cover. The Vietnamese Ministry of National Defense Air Defense Air Force Command then cleared the area of unexploded ordnance (UXO). Excavation of the contaminated soil in this area commenced on May 28.

UXO clearance

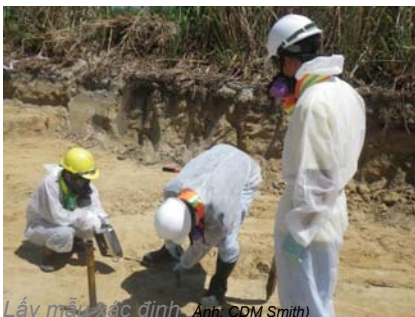
Lấy mẫu xác định. (Ảnh: CDM Smith)

Các nhà thầu của USAID tiếp tục quan trắc, kiểm tra và thử nghiệm rộng rãi nhằm đảm bảo chất nhiễm bẩn không thoát ra khỏi khu vực dự án, và các hoạt động thi công đáp ứng tiêu chí thiết kế. Ngoài ra, các nhà thầu của USAID tiếp tục lấy mẫu đất xác định từ chu vi và đáy khu vực đào xúc nhằm đảm bảo đã đào xúc toàn bộ chất nhiễm bẩn. Mọi công việc lấy mẫu xác định được thực hiện trong sự phối hợp chặt chẽ với Bộ Tư lệnh Hóa học thuộc Bộ Quốc phòng Việt Nam và Trung tâm Nhiệt đới Việt-Nga.

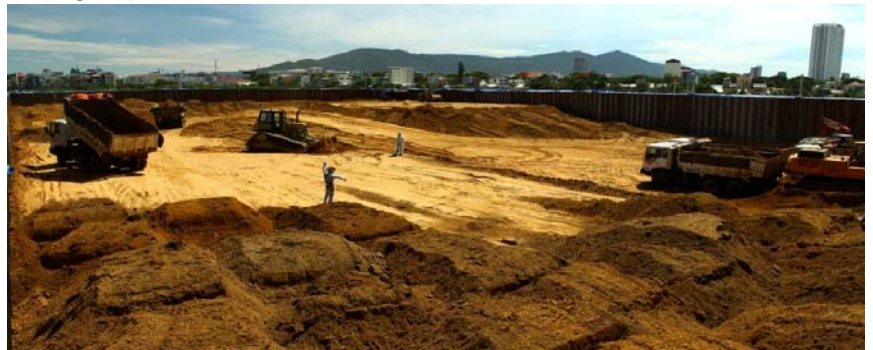
Trong tháng 6 năm 2013, các nhà thầu của USAID tiếp tục thi công kết cấu móng, tiếp tục đào xúc đất bị nhiễm bẩn gần đường lăn sân bay, bắt đầu vận chuyển đất và bùn bị nhiễm bẩn từ khu vực lưu trữ trước đây và vùng đất ngập phía nam đưa vào trong kết cấu móng (xem ảnh dưới). Trong khi tiến hành các hoạt động này, nước được phun lên đất và bùn để ngăn bụi bay lên không khí. Tính đến ngày 30 tháng 6, bùn và đất đã được đưa vào khoảng 50 phần trăm thể tích kết cấu móng.

Đưa đất và bùn bị nhiễm bẩn vào kết cấu móng

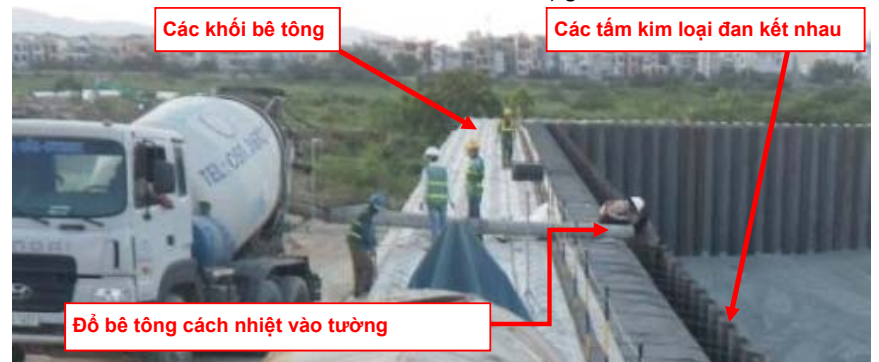
Các tường bên của kết cấu móng (gồm các khối bê tông, bê tông cách nhiệt và các tấm kim loại đan kết nhau – xem ảnh dưới) gần được hoàn tất.

Các khối bê tông

Các tấm kim loại đan kết nhau

Đổ bê tông cách nhiệt vào tường

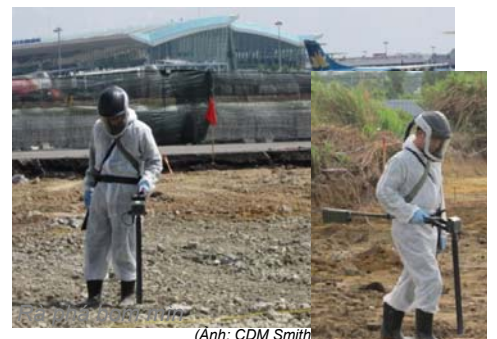
Trước khi bắt đầu đào xúc đất ở khu vực pha trộn và chuyển tải trước đây gần đường lăn sân bay, các nhà thầu của USAID đã phá dỡ và vận chuyển an toàn tấm phủ bê tông. Sau đó Bộ Tư lệnh Phòng không-Không quân thuộc Bộ Quốc phòng đã tiến hành rà phá bom mìn. Ngày 28 tháng 5, bắt đầu đào xúc đất bị nhiễm bẩn ở khu vực này.
