**International
Hurricane Research
Center**

Shelter and Component Testing OFDA transitional shelters: materials, techniques and structures

Shelter and Component Testing OFDA transitional shelters: materials, techniques and structures (Supplementary Test)

Project Number: WOW12-2012-02-A

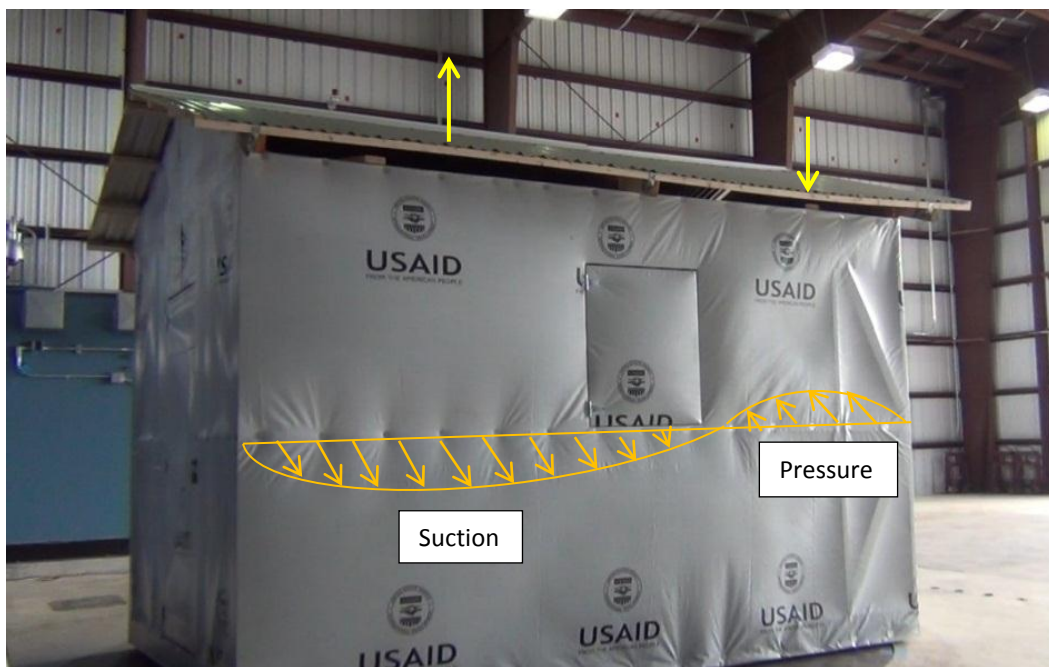
Figure 5 - T-Shelter 3 test at 85 mph and 90° angle of attack

The deformation of the plastic sheeting suggested that when the wind had a 90° angle of attack, the flow separated near the leading edges and reattached further downwind. This is shown on Figure 5: bloated plastic surfaces at the windward side (suction) and plastic being pushed against the frame on the back (pressure). The roof also seemed to be susceptible to this effect, particularly with the long unsupported spans of roof structure. The edge purlins can be seen deforming by the action of the wind-induced forces.

The goal was to prove that a stronger roof structure with the same spacing as T-Shelter 1 (weak construction T-Shelter from previous experiments) should be able to withstand hurricane force winds. Even with its stronger construction, large unsupported spans allow for greater deformations and flexibility. The vulnerability can be decreased by adding more trusses and reducing the clear spacing by half.

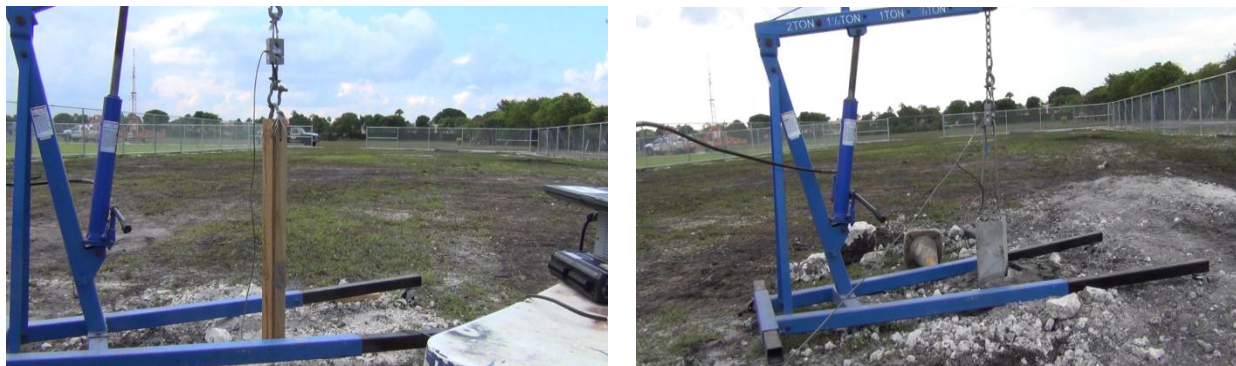
Figure 15 – Pull-out test of footings with hydraulic jack. Left: 4x4 embedded in concrete, right: precast concrete pier

The experimental data shows (Figure 16) that the precast concrete pier required the lowest amount of force to pull the footing out of the ground. It is evident that the characteristics of the ground surrounding the excavated hole affected the performance of the precast concrete pier. The effective preconsolidation ratio of the rock (gravelly soil) achieved by manually compacting the backfill is less than that achieved by mechanical compaction or in an undisturbed and cohesive soil. The ultimate tension load the precast concrete pier held is 1712 lbs...

With the concrete-embedded 4x4's and 4x4's with nails, the pull out forces measured were substantially larger. The steel wire rope connection between the hydraulic jack, load cell and specimen was the weak link of the setup. The 3/8-in steel cable snapped in one case and the clamp and thimble (wire rope connection) fractured in the second. The ultimate load recorded while pulling the cast-in-place foundations are 3089 lbs. and 2904 lbs. for the 4x4 with nails and 4x4 embedded in concrete, respectively. These forces represent the highest force achieved before the cable broke and not the ultimate strength of the footing. The footings did not visibly move, even at the highest tension load.

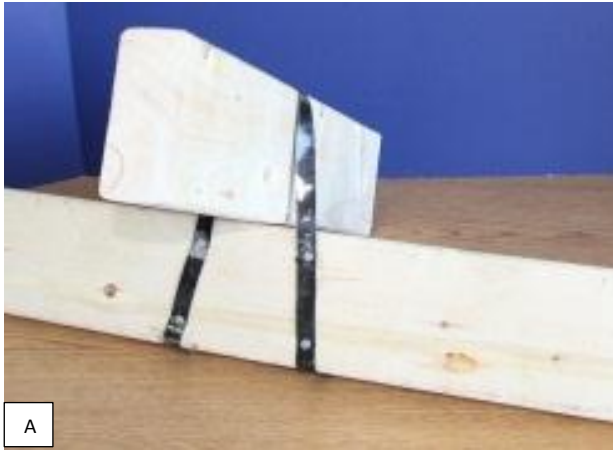
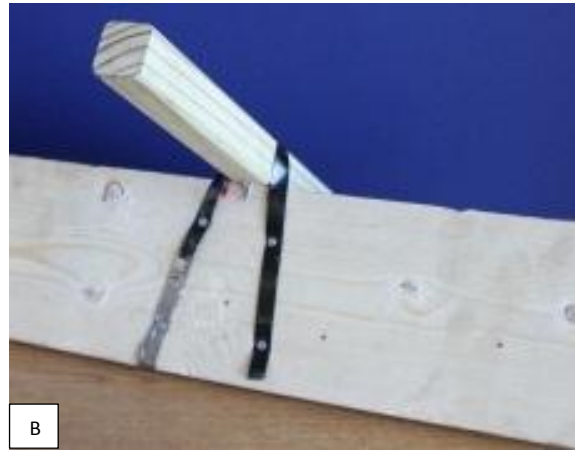
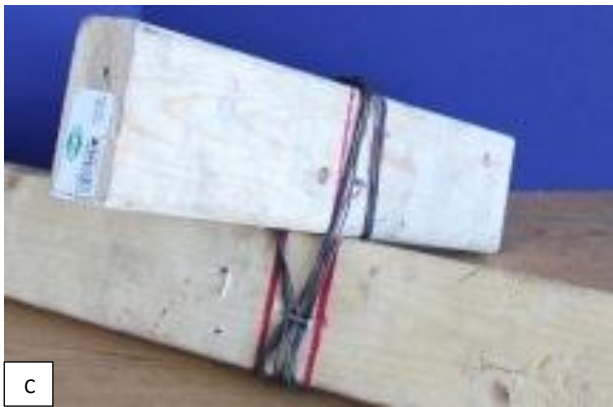
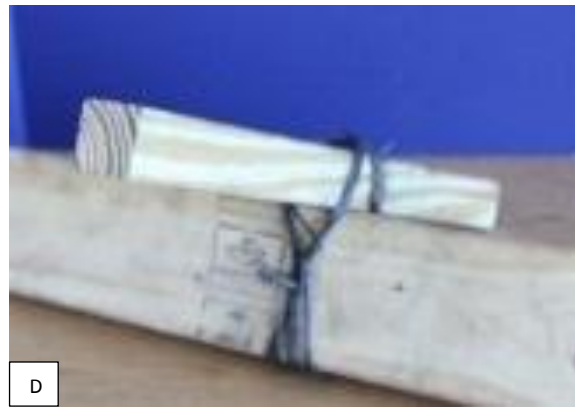
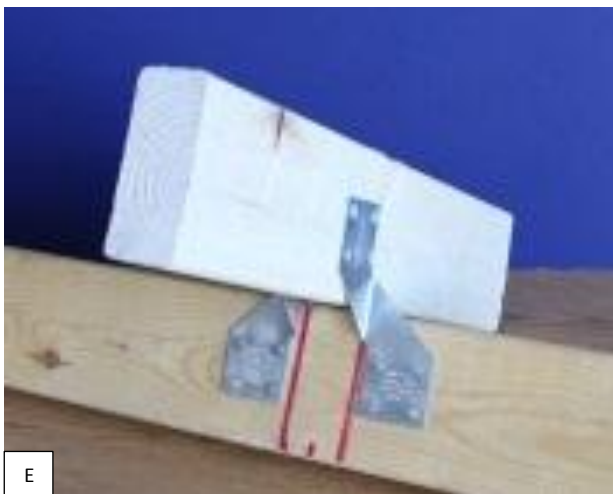
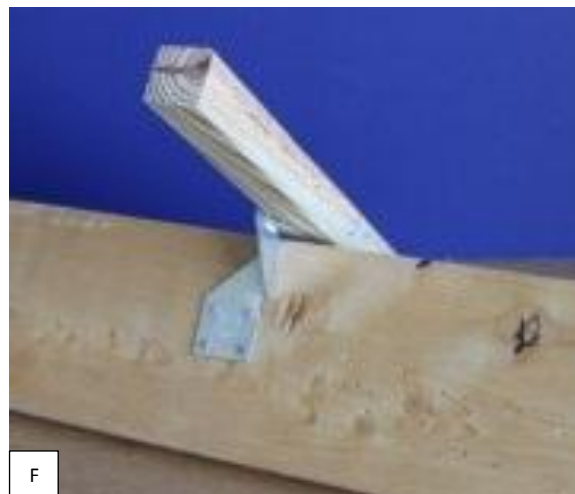
Figure 17 – Hurricane strapping techniques: (A) metal straps on 2-inx4-in, (B) metal strap on 2-inx2-in and 1-inx6-in, (C) metal wire on 2-inx4-in, (D) metal wire on 2-inx2-in and 2-inx4-in, (E) engineered tie on 2-inx4-in and (F) engineered tie on 2-inx2-in and 1-inx6-in

The different strapping methods yielded resistance to tension forces from as low as 462 lbs. up to 3000 lb. The highest resistance was achieved by a nontraditional technique: steel wire wrapped around the 2x4 members 8 times. This technique does not penetrate the lumber with nails and weaken the member. The engineered hurricane ties and the metal strap do penetrate the wood members, predetermining a fracture point in the wood. The steel wire connection was able to reach 3014 lbs. of

Most of the connection techniques done between 2x4 lumbers were able to reach loads close to 2000 lbs. before failing. The lumber would split at the points where a nail was driven into the wood before the connection material or fasteners failed. Weaker lumber members broke before any other components of the connection. It was evident that the 2x2's made the connection weaker, where none of the connections were able to take more than 1400 lbs... Most of these systems failed at loads less than 1000 lbs., except the ones with the wrapped steel wire. It is believed that the steel wire distributes the load around the slenderer lumber and also does not weaken it with multiple nail penetrations.

Even though the steel wire provided the best tension resistance, its performance depends on the number of wraps around the lumber and the method used to secure the loose ends. This factor will vary depending on the quality of the installation and the number of wire strands securing the connection. It will be contingent to the consistency of the wire wrap and its tightness around the lumber. This technique showed the biggest deformation presenting a big gap between the members before the wire started to break. This deformation may allow the members to slide within the connection if additional forces are present before the strapping can be fixed. Table 3 shows the ultimate strength in pounds achieved by each of the connections and the type of failure observed on the different hurricane strapping connections.

The preferred method to strap the roof to be included in the full scale T-shelter model test is the metal strap. Even though the engineered tie provides good resistance to tension loads, the size and pattern of the nails create a fracture plane on the lumber. Also it requires the installer to follow the correct instructions and application guidelines. Otherwise connections might be ineffective due to incorrectly sized lumber members and fasteners that might cause a connection or component failure.

The metal strap does not provide a predetermined nailing pattern and does not require a highly technical knowledge to install it. It also gives flexibility as to the installation location and number of fasteners to use. Also it was preferred over the steel wire because it is made of galvanized metal (corrosion resistant) and did not allow displacement of the members at the connection.

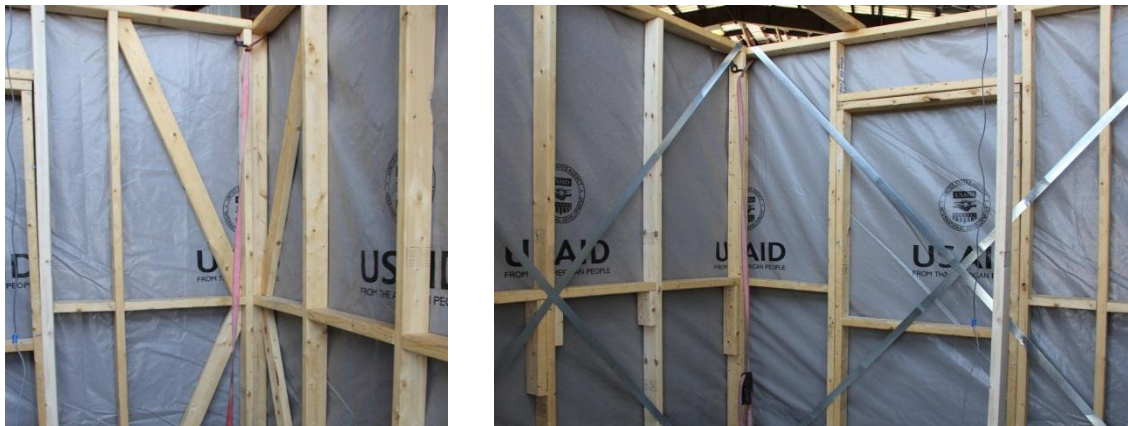
Figure 18 – Wall bracing techniques: corner diagonal wood braces (left) and metal strap diagonal X brace

Both metal strap and wood braces performed well in avoiding big deformations on the wall panels when submitted to wind induced horizontal (shear) loads. The metal strap X brace did allow deformation approximately 0.6-in greater than with the wood braces. During the wind loading one of the metal X braces became loose when the fasteners were pulled out of the wood. This can be seen in Figure 19 where the incremental deformation measured between 60 to 70 mph was substantially bigger than the with the other speed increments. The displacement measured is approximately 1.30-in, when with the other speed increments the displacement ranged between 0.02 and 0.2-in.

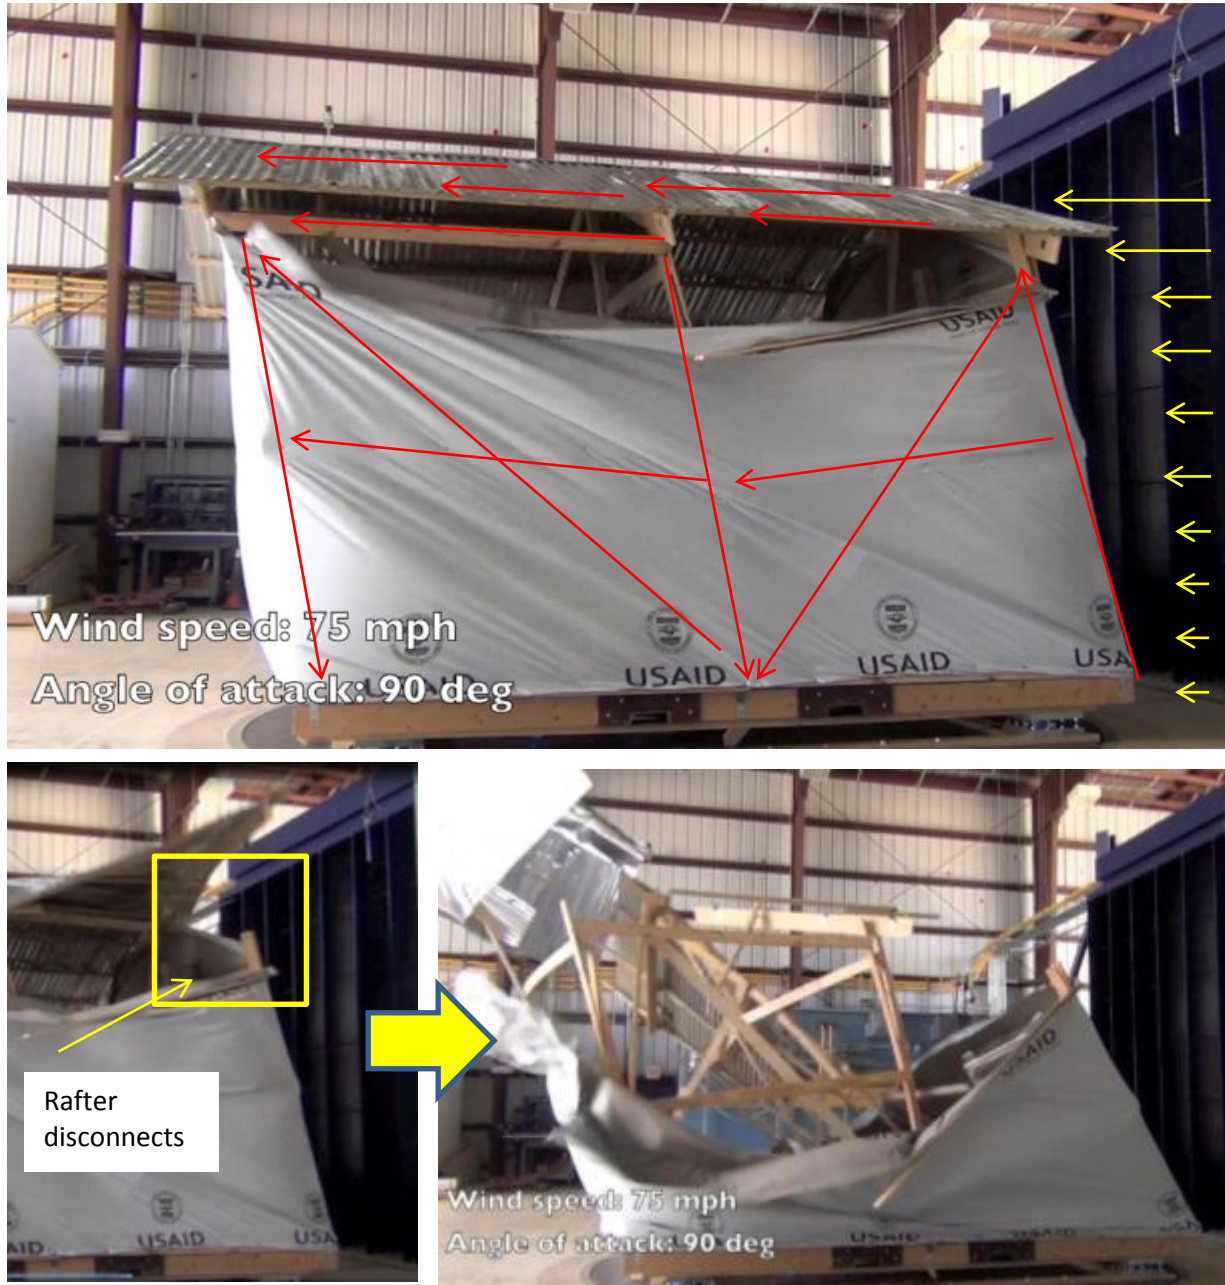
When T-Shelter 1 was tested at 75 mph and 90°, the detached horizontal members had already weakened the frame. These members added strength to the shelter on the along-wind direction at this angle of attack. The roof purlins and cladding were able to distribute the load among the vertical structural members and held the walls together. Without horizontal braces, the walls had no ability to sustain the wind induced loads without lateral bracing and simple supports at the base. When the roof structure connection failed at one of the windward corners, the shelter lost the ability to withstand the wind loads and collapsed (See Figure 25). The walls, at this point, were comprised of weakened vertical studs and the number of horizontal members and diagonal bracing between the vertical studs was greatly reduced. Also, the large span between vertical studs allowed for greater flexibility of the structure and considerable deflections that might have contributed to the smooth shank nails pulling out of their connections. The resistance of the shelter could be easily and cost-effectively improved by

Figure 25 - Redistributed load path on T-Shelter 1 model

increasing the lumber size and providing stronger connections made with ring shank nails. Also this framing system with multiple nailed connections is weaker than solid lumber elements. A substantial improvement can be achieved by modifying the construction method to minimize the number of nailed connections and strengthen the connections between structural components.

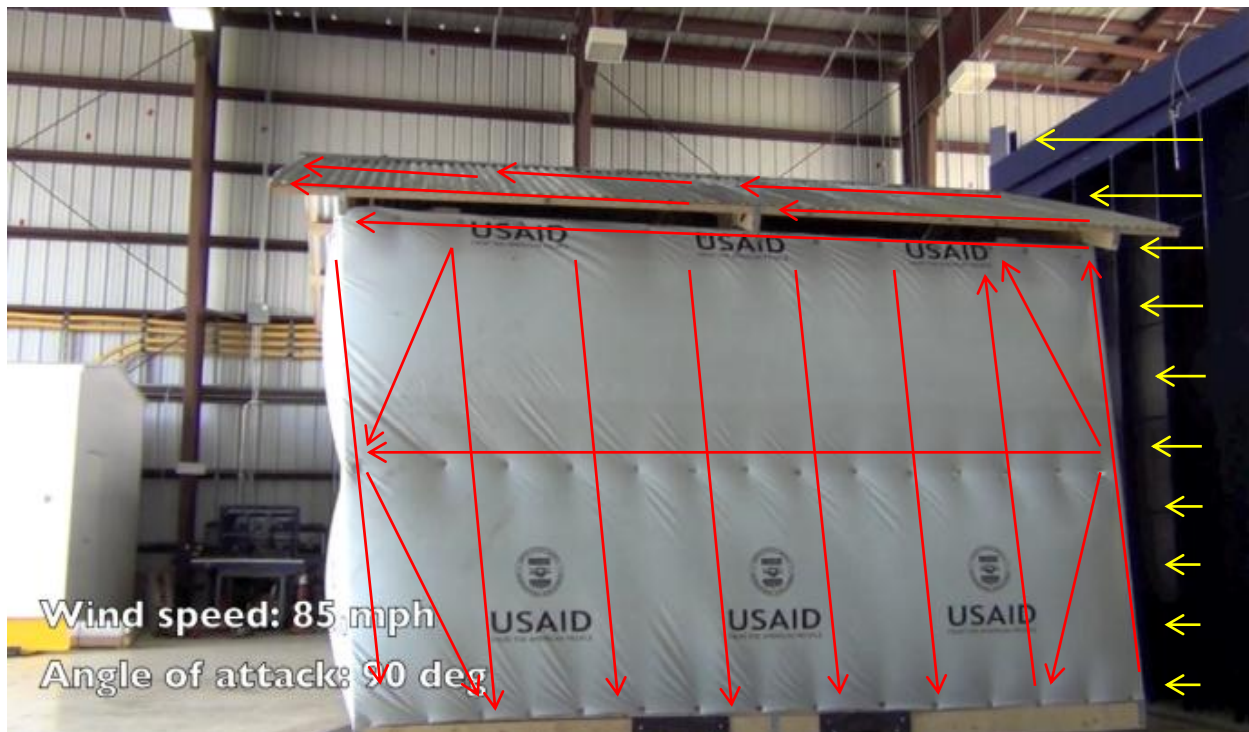
At 75 mph and 90 degrees a slight inclination of the shelter can be seen suggesting racking due to insufficient lateral bracing. High frequency vibrations can be seen on the roof purlins. This effect is produced by the longer than normal unsupported span between trusses. The shelter was built this way to prove that a stronger roof structure (a 2-in x 4-in truss vs. a 1-in x 6-in stick built rafter and joist frame) will provide sufficient strength with the same clear spacing. By providing two more trusses and reducing the clear spacing from 7-ft to 3.5-ft the robustness of the roof can be greatly increased.

Figure 26 - T-Shelter 2 load distribution path at 85 mph

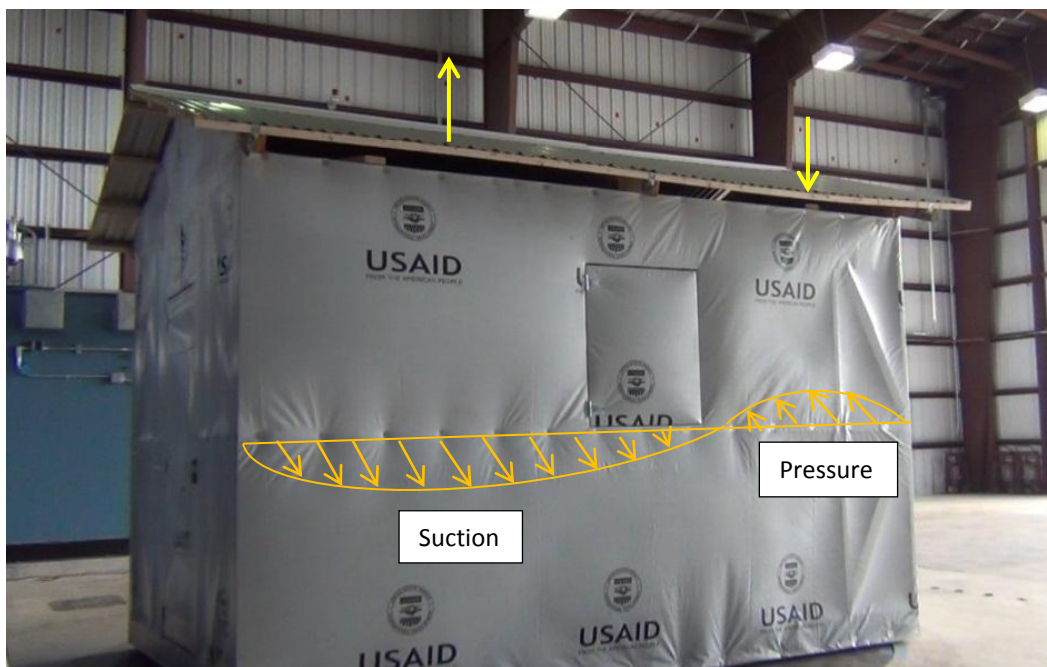
The deformation of the plastic sheeting suggested that when the wind had a 90° angle of attack, the flow separated near the leading edges and reattached further downwind. This is shown on Figure 5: bloated plastic surfaces at the windward side (suction) and plastic being pushed against the frame on the back (pressure). The roof also seemed to be susceptible to this effect, particularly with the long unsupported spans of roof structure. The edge purlins can be seen deforming by the action of the wind-induced forces.

The goal was to prove that a stronger roof structure with the same spacing as T-Shelter 1 (weak construction T-Shelter from previous experiments) should be able to withstand hurricane force winds. Even with its stronger construction, large unsupported spans allow for greater deformations and flexibility. The vulnerability can be decreased by adding more trusses and reducing the clear spacing by half.

Figure 5 - T-Shelter 3 test at 85 mph and 90° angle of attack
