ENCAP Visual Field Guide: CONSTRUCTION

for quick identification of serious environmental & occupational health and safety concerns in small-scale construction

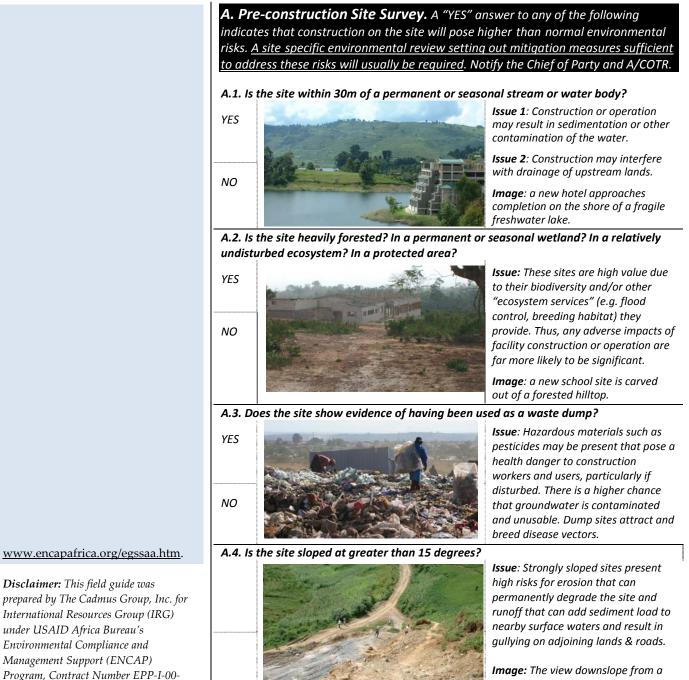
A.5. Is the site occupied or cultivated?

Image: The view downslope from a hilltop construction site shows erosion and runoff channels.
