Vietnam: Environmental Remediation of Dioxin Contamination at Danang Airport

Progress Report: August 1, 2013 to August 31, 2013

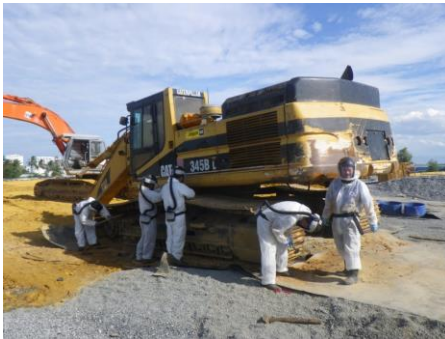
Decontaminating equipment before leaving project area (Photo: CDM Smith)

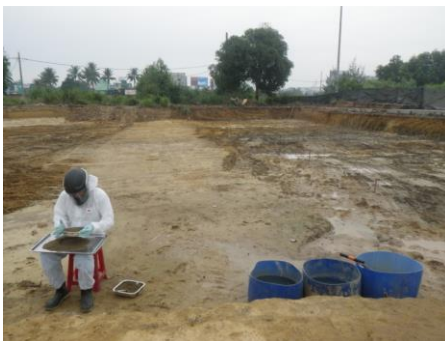
In addition, USAID contractors, in coordination with the Vietnamese Ministry of National Defense Chemical Command and the Vietnam-Russia Tropical Center, continued to collect confirmation soil samples from excavation boundaries to verify removal of all contaminated soil and sediment above cleanup goals.

Collecting and processing confirmation soil samples (Photo: CDM Smith)

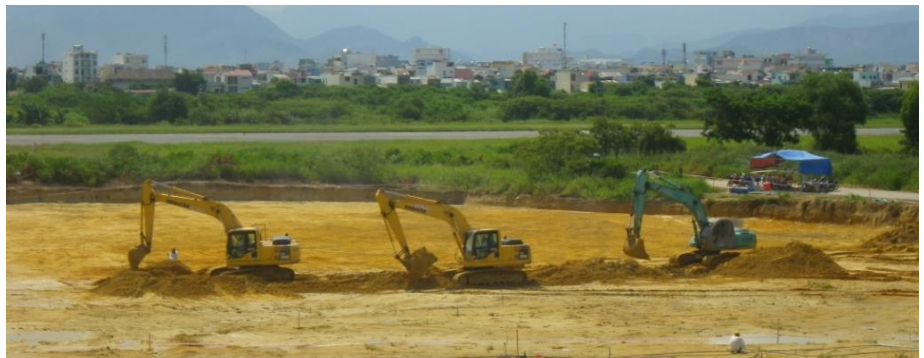
Confirmation soil sample results indicated successful excavation of all contaminated material in some areas, while results in other areas indicated that additional excavation was required. For example, confirmatory sampling results collected at Pacer Ivy Storage Area by both USAID and Vietnam-Russia Tropical Center indicated dioxin concentrations well below the clean up goal. USAID completely backfilled and planted grass to restore this area. In other areas, including the Storage Area, contractors continued to excavate additional soil. Confirmation soil sampling will be performed to verify removal of contaminated soil above the cleanup goal.

Conducting additional excavation to remove contaminated soil in the Storage Area (Photo: CDM Smith)

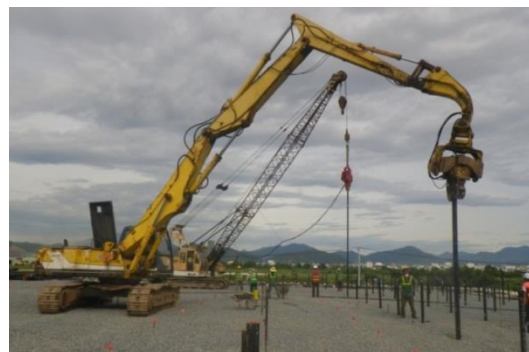
Installing heaters into pile structure (Photo: CDM Smith)

USAID contractors continued receiving thermal treatment equipment at the project site and began installing the thermal treatment system heaters into the filled pile structure.

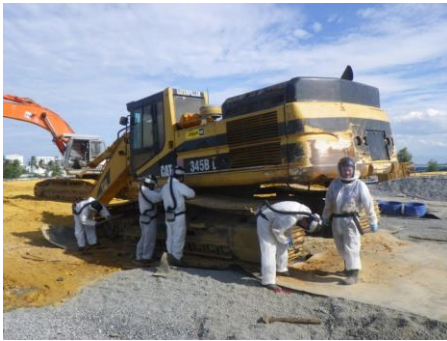
Làm sạch thiết bị trước khi rời khỏi công trường (Ảnh: CDM Smith)

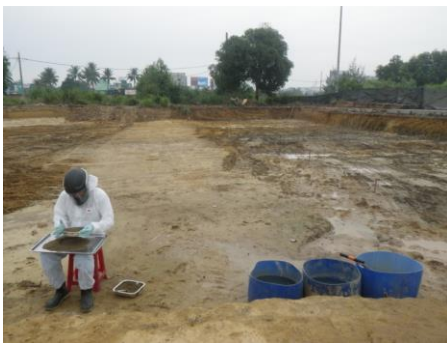
Ngoài ra, các nhà thầu của USAID phối hợp với Bộ Tư lệnh Hóa học thuộc Bộ Quốc phòng Việt Nam và Trung tâm Nhiệt đới Việt-Nga tiếp tục lấy mẫu đất xác nhận từ chu vi và đáy khu vực đào xúc nhằm đảm bảo đã đào xúc toàn bộ lượng bùn đất có nồng độ nhiễm bẩn cao hơn mục tiêu làm sạch.

Lấy mẫu và xử lý mẫu đất xác nhận (Ảnh: CDM Smith)

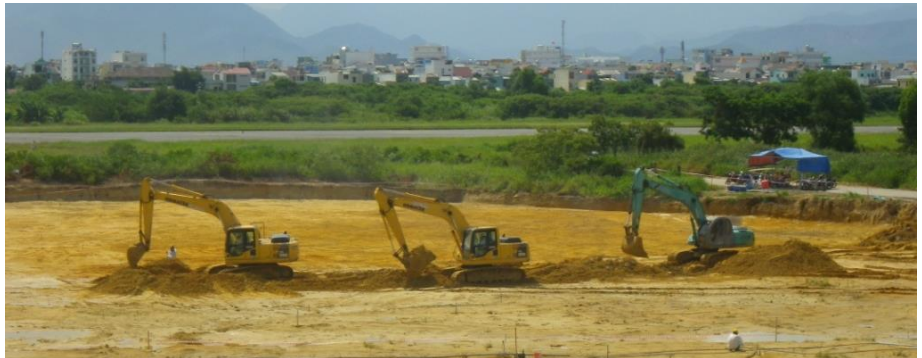
Kết quả thử nghiệm trên các mẫu xác nhận cho thấy nhiều khu vực đã được đào xúc toàn bộ chất nhiễm, trong khi kết quả ở một số khu vực khác cho thấy cần phải đào xúc thêm bùn đất để xử lý. Ví dụ, kết quả phân tích của USAID và Trung tâm Nhiệt đới Việt-Nga đối với các mẫu xác nhận ở Khu Lưu trữ Ivy cho thấy nồng độ dioxin thấp hơn nhiều so với mục tiêu làm sạch. USAID đã lấp lại hoàn toàn và trồng cỏ để phục hồi khu vực này. Nhà thầu đang tiếp tục đào xúc thêm ở những khu vực khác, kể cả Khu Lưu trữ. Việc thử nghiệm mẫu xác nhận sẽ được thực hiện nhằm đảm bảo lấy đi hết đất có nồng độ nhiễm bẩn cao hơn mục tiêu xử lý.

Đào xúc thêm để mang đi xử lý đất bị nhiễm bẩn ở Khu Lưu trữ (Ảnh: CDM Smith)

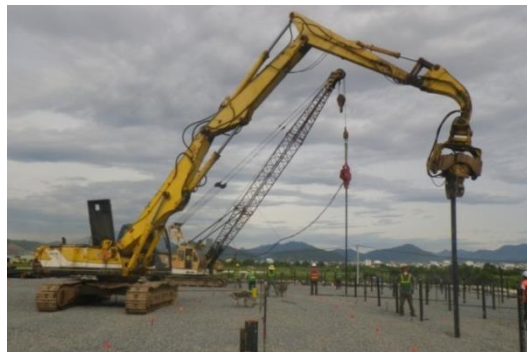
Đặt giếng truyền nhiệt vào móng xử lý (Ảnh: CDM Smith)

Các nhà thầu của USAID tiếp tục nhận thiết bị xử lý nhiệt tại công trường dự án, và bắt đầu lắp đặt các giếng truyền nhiệt vào kết cấu đã được chất bùn đất cần xử lý.
