## Progress Report: July 1, 2015 to September 30, 2015

USAID and the Government of Vietnam continued implementing the Environmental Remediation of Dioxin Contamination at Danang Airport Project, launched in August 2012.

## Báo cáo Tiến độ: 1 tháng 7 năm 2015 đến 30 tháng 9 năm 2015

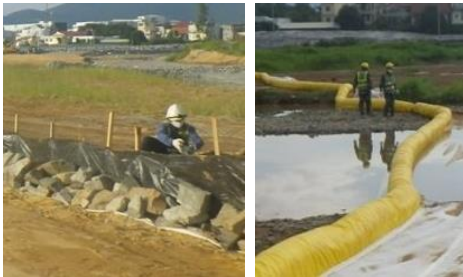
Erosion control measures – silt fences (left) and turbidity barriers (right) (Photos: CDM Smith)

USAID contractors installed and continuously inspected and maintained erosion control measures for the Phase 2 temporary stockpile storage areas to prevent potential offsite migration of contaminants from the stockpiles.

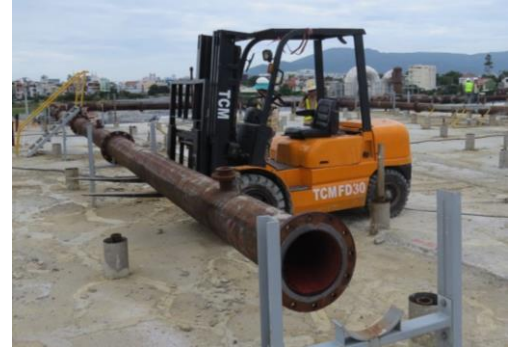
Removing vapor manifold from Phase 1 treatment structure (Photo: CDM Smith)

From July 17 through August 6, 2015, USAID contractors removed, extracted and cleaned equipment from the Phase 1 thermal treatment system.

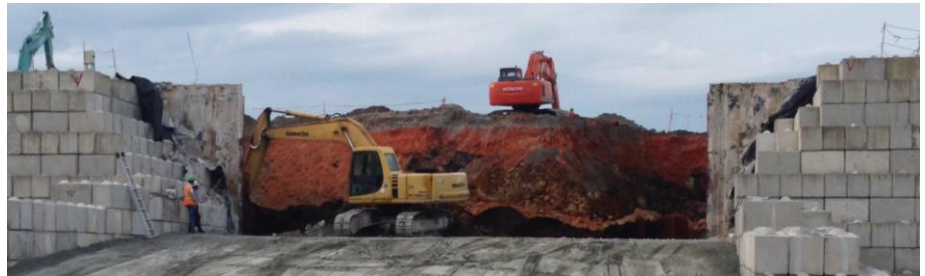
Removing Phase 1 treated soil and sediment from the south wall of the thermal treatment structure (Photo: USAID)

The concrete cap was then removed from the surface of the treatment structure to allow USAID contractors access to remove the treated soil and sediment (less than 10 parts per trillion of dioxin on average). Initially, the treated material was removed from the top of the pile, and when safe to do so, the southern wall of the structure was opened to allow for easier and faster removal of the treated soil and sediment. The treated material is expected to be completely removed from the structure by November 2015 and is being temporarily stockpiled in the former Storage Area at the Project site, pending beneficial reuse as clean backfill for the Danang International Airport's expansion project. USAID is working in close coordination with the Vietnamese Airports Corporation of Vietnam and Vietnamese Project partner, Air-Defense-Air Force Command, to manage the backfilling effort.

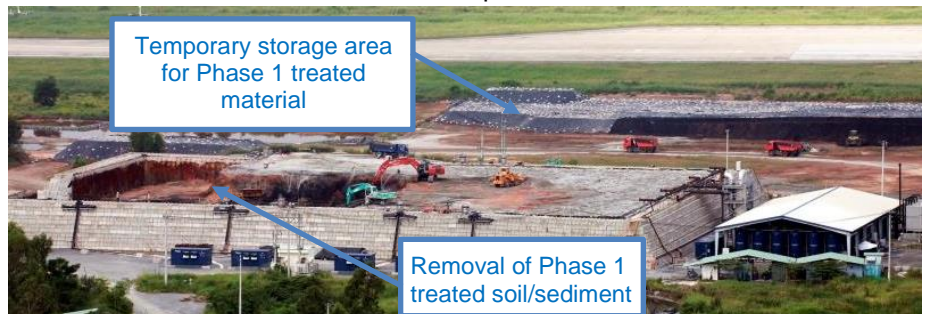
Temporary storage area for Phase 1 treated material

Removal of Phase 1 treated soil/sediment

Removal and temporary storage of Phase 1 treated material (Photo: Tetra Tech)

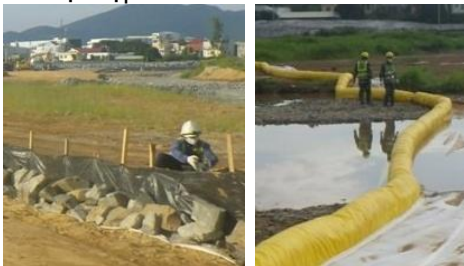
Kiểm soát xói lở – rào chắn bùn (trái) và bờ bao ngăn nước đục (phải) (Ảnh: CDM)

Các nhà thầu của USAID đã lắp đặt, thường xuyên kiểm tra và bảo dưỡng các biện pháp kiểm soát xói lở cho khu vực tập kết tạm Giai đoạn 2 nhằm kiểm soát sự phát tán của chất nhiễm bẩn từ khu vực tập kết.

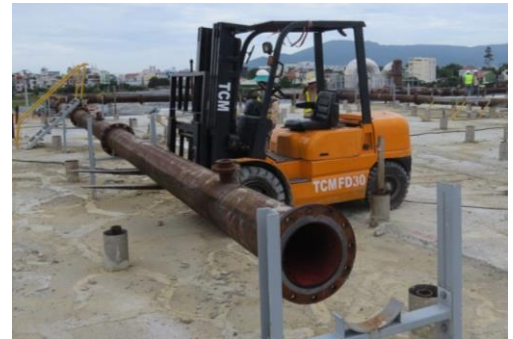
Tháo dỡ đường ống dẫn hơi nước từ kết cấu xử lý Giai đoạn 1 (Ảnh: CDM Smith)

Từ ngày 17/7 đến ngày 6/8/2015, các nhà thầu của USAID đã tháo dỡ, chuyển thiết bị từ hệ thống xử lý nhiệt ra để làm sạch.

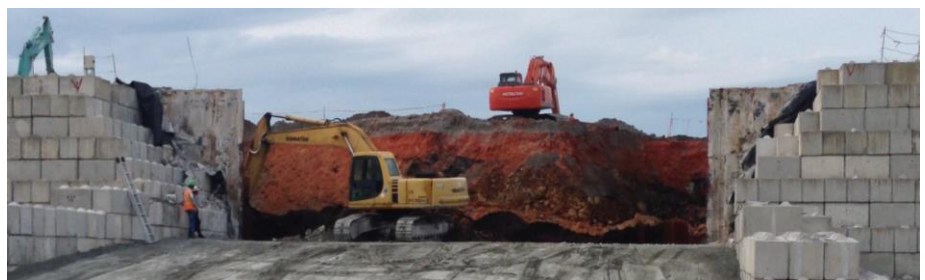
Tháo dỡ đất và bùn đã qua xử lý Giai đoạn 1 từ vách phía nam của kết cấu xử lý nhiệt. (Ảnh: USAID)

Sau đó nắp bê tông được tháo dỡ từ bề mặt của kết cấu xử lý để tạo lối tiếp cận cho các nhà thầu của USAID chuyển đất và bùn (chứa trung bình không tới 10 phần nghìn tỉ (ppt) dioxin) ra. Đầu tiên vật liệu đã qua xử lý được xúc ra từ mặt trên của mố, rồi khi thấy an toàn, phần vách phía nam của kết cấu được mở ra để tháo dỡ đất và bùn đã qua xử lý ra được nhanh và dễ dàng hơn. Dự kiến đến tháng 11/2015, toàn bộ đất và bùn đã xử lý sẽ được chuyển ra khỏi kết cấu rồi tập kết tạm thời tại khu vực lưu trữ trước đây trong công trường trong khi chờ tái sử dụng làm vật liệu sạch để hoàn thổ phục vụ dự án mở rộng Sân bay Quốc tế Đà Nẵng. USAID đang phối hợp chặt chẽ với Tổng công ty Hàng không Việt Nam và đối tác phía Việt Nam, Bộ Tư lệnh Phòng không-Không quân, trong việc quản lý công tác hoàn thổ.

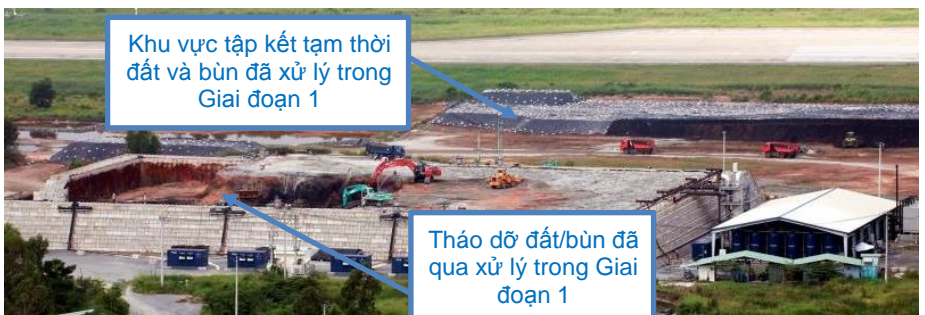
Khu vực tập kết tạm thời đất và bùn đã xử lý trong Giai đoạn 1

Tháo dỡ đất/bùn đã qua xử lý trong Giai đoạn 1

Tháo dỡ và tập kết tạm thời đất và bùn đã xử lý trong Giai đoạn 1
